January 9, 2024

Memorandum – Budlong Park Pool, Cranston RI – Historical Review

In July 2023, Weston & Sampson was tasked to review the current conditions of the facility to understand the viability rehabilitation or replacement. Below are our findings from that site visit.

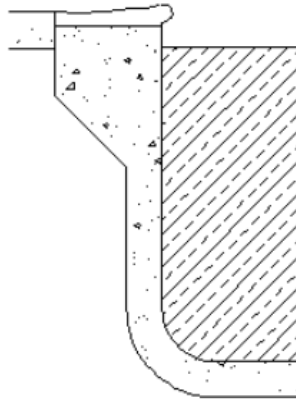
Figure 4.5.12.1: Plumb Pool Walls: Cross-Section

14. On the deep end pool wall there is a wall obstruction. It appears to be part of the pool as the pool was liner-ed over it. This a violation of MAHC [4.5.12.4](#) – No Protrusions, Extensions, Means of Entanglement, or Obstruction. This requires walls to be within +/- 3 Degrees in vertical tolerance. There are areas of the shallow that seem to be more than 3 % of tolerance.

Plumb within a +/- 3 degree tolerance.
