**R.I. DEPARTMENT OF ENVIRONMENTAL MANAGEMENT
OFFICE OF WATER RESOURCES PERMITTING SECTION
FRESHWATER WETLANDS PROGRAM
APPLICATION INSPECTION REPORT**

Application No.: 16-0202 **Applicant Name:** DSM Realty Corporation

SITE INSPECTION REPORT

File Name: DSM Realty Corp (Gold Meadow Farms Solar Array Project)

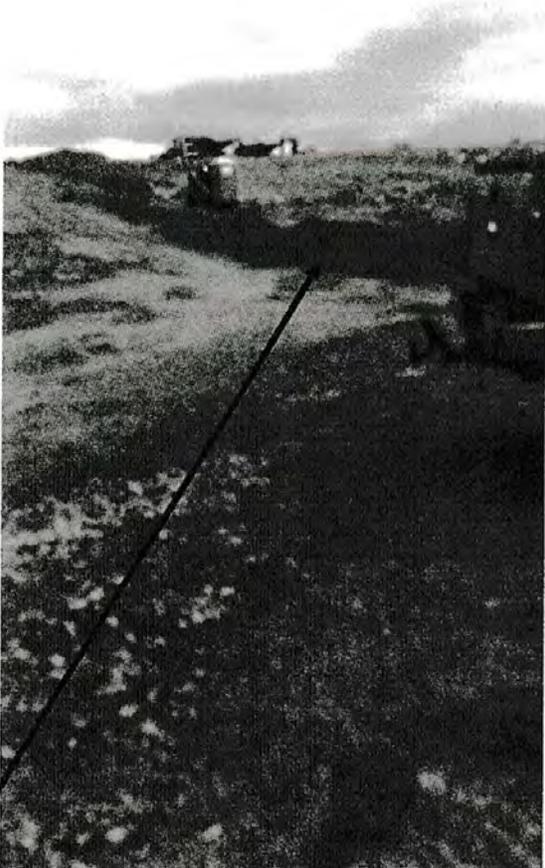
Picture 2-Berm created as an attempt to re-route site drainage from main breach point

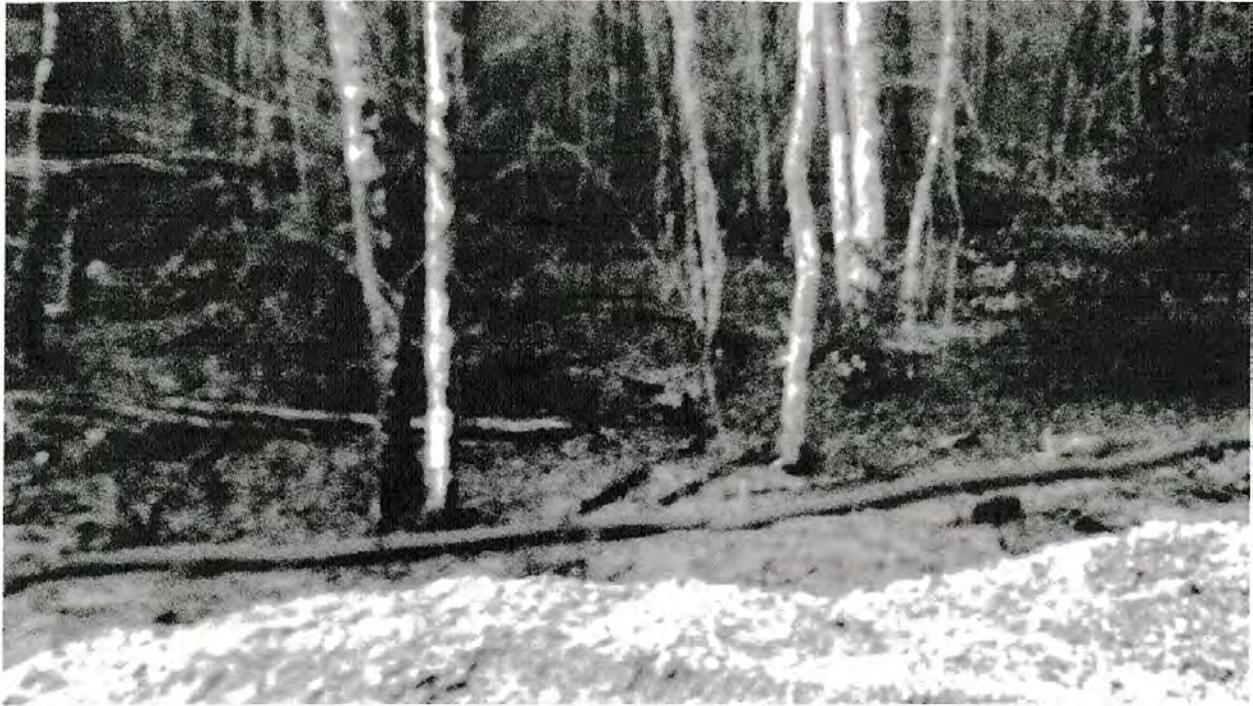
Picture 3-facing west towards the D-Series swamp from near the large fill piles.

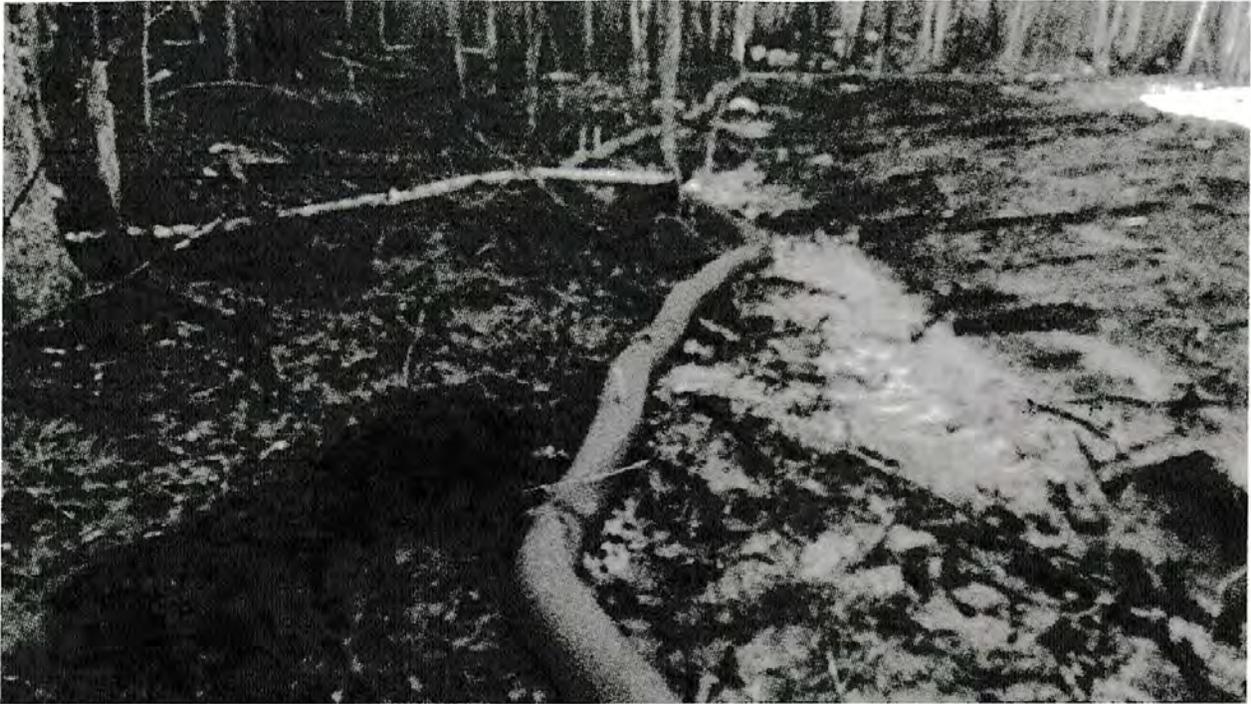
- Erosion controls have been breached resulting in some sedimentation into isolated forested wetland "Z" (see-picture 5). A review of the adjacent lobe of D-Series swamp (~Flags D-30 through D45) did not reveal the presence of any sedimentation.

Picture 5-sediments accumulated into Wetland Z (Forested Wetland)

- d. Wetland Z: remove accumulated sediments along the outer edge by hand or from a piece of equipment operating from the adjacent upland.

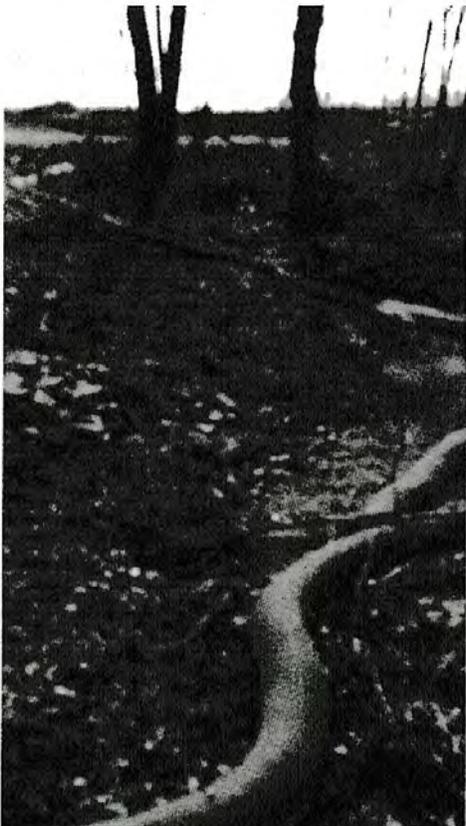
Picture 6-Breach near up to and within outer portions of isolated forested wetland H. Mulched chips and stone placed to prevent erosion.

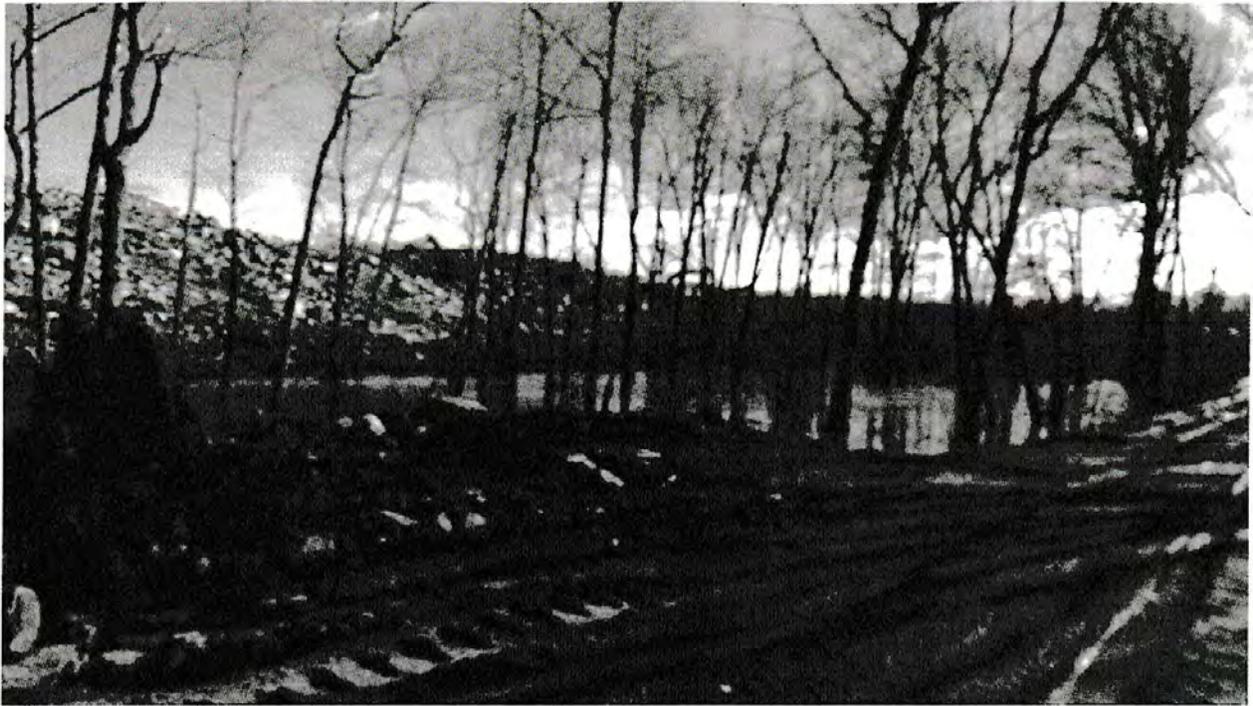
Picture 7: Wetland F (Forested Wetland)

- Erosion controls protecting isolated Forested Wetlands E and F are grossly inadequate based on fill slope bounding the F-series Wetland in particular (see picture 7, 8 and 9). Both wetlands appear to be functioning more as detention basins with hydrologic conditions appearing artificially high. There appears to be an increase in the quantities and flow rates of surface water entering these isolated wetlands.

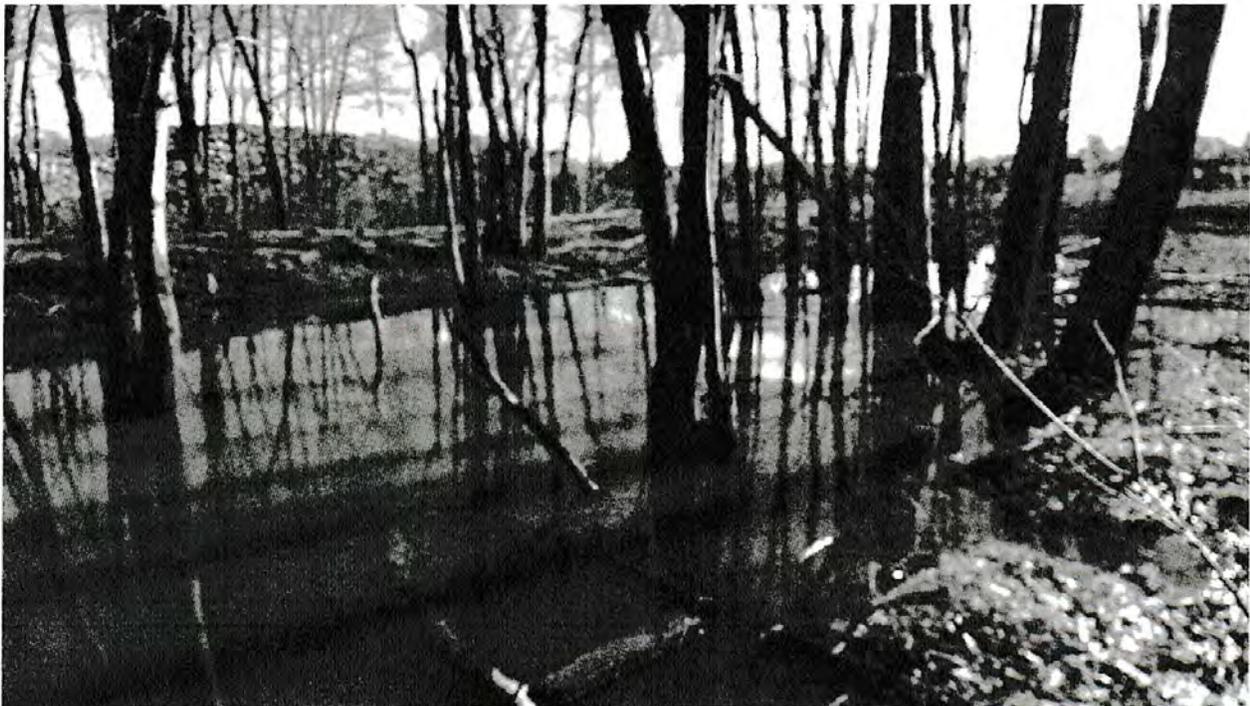
Picture 8: Wetland E (Forested Wetland-an existing cartpath separates these tow wetlands)

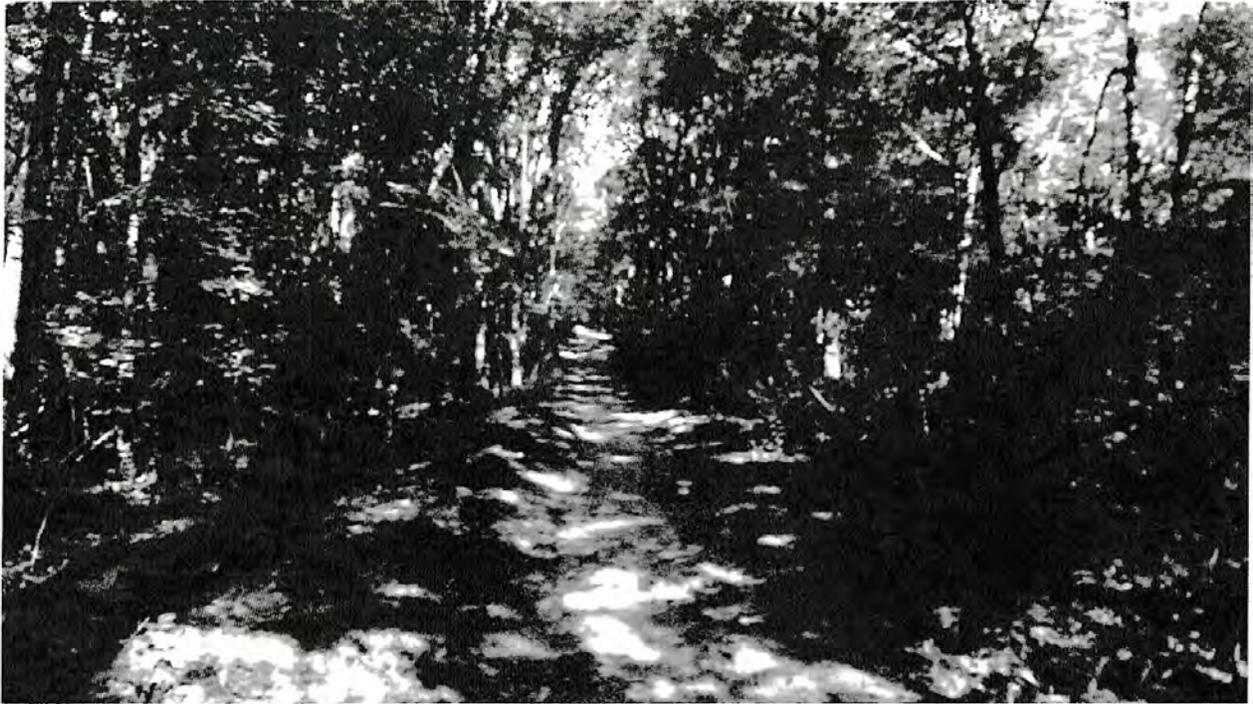
Picture 9: Pre-construction cartpath between Wetlands E and F during growing season

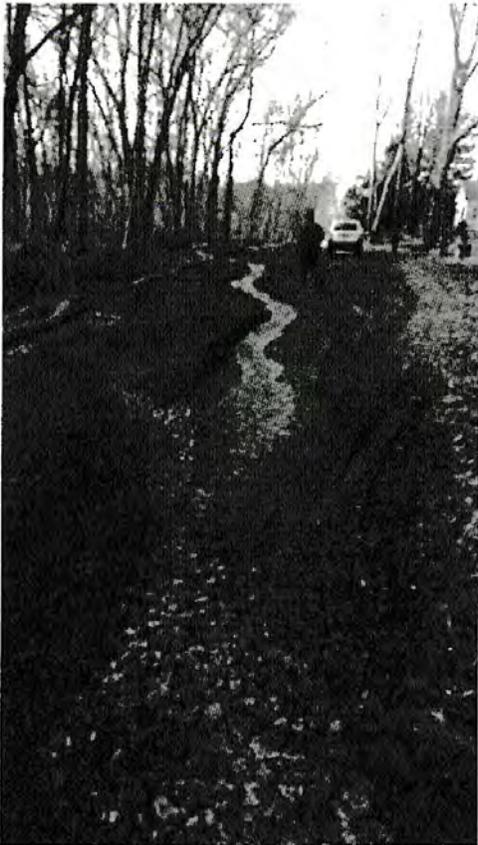
Picture 10-access road

- Drainage is flowing down the access road, rather than across it (see-picture 10). A channel flows from the woods to the north of the road down slope and into the road. There is a dry channel across the street that loses definition shortly thereafter. While the channel is likely an ASSF, there are no wetlands immediately along the road in this location. Drainage is flowing down the street towards Lippett Avenue. Filter socks are directing flow into the woods further west than the established flow path. The roadbed is being further undermined by a sump pump draining from a residence onto the road.

1/25/2018: Dave Russo from DiPrete Engineering left a message regarding my site visit and specifically regarding the access road. Additional rain is in the forecast and the property owner is requesting to install a culvert(s) at the ASSF crossing to prevent further washout. Per discussion with the Program Supervisor, the installation of a culvert (or a couple small culverts) is acceptable given the circumstances and provided that drainage is directed to its existing, established flow path. The installation of culverts will help to prevent roadway sediments from entering any downstream wetlands.

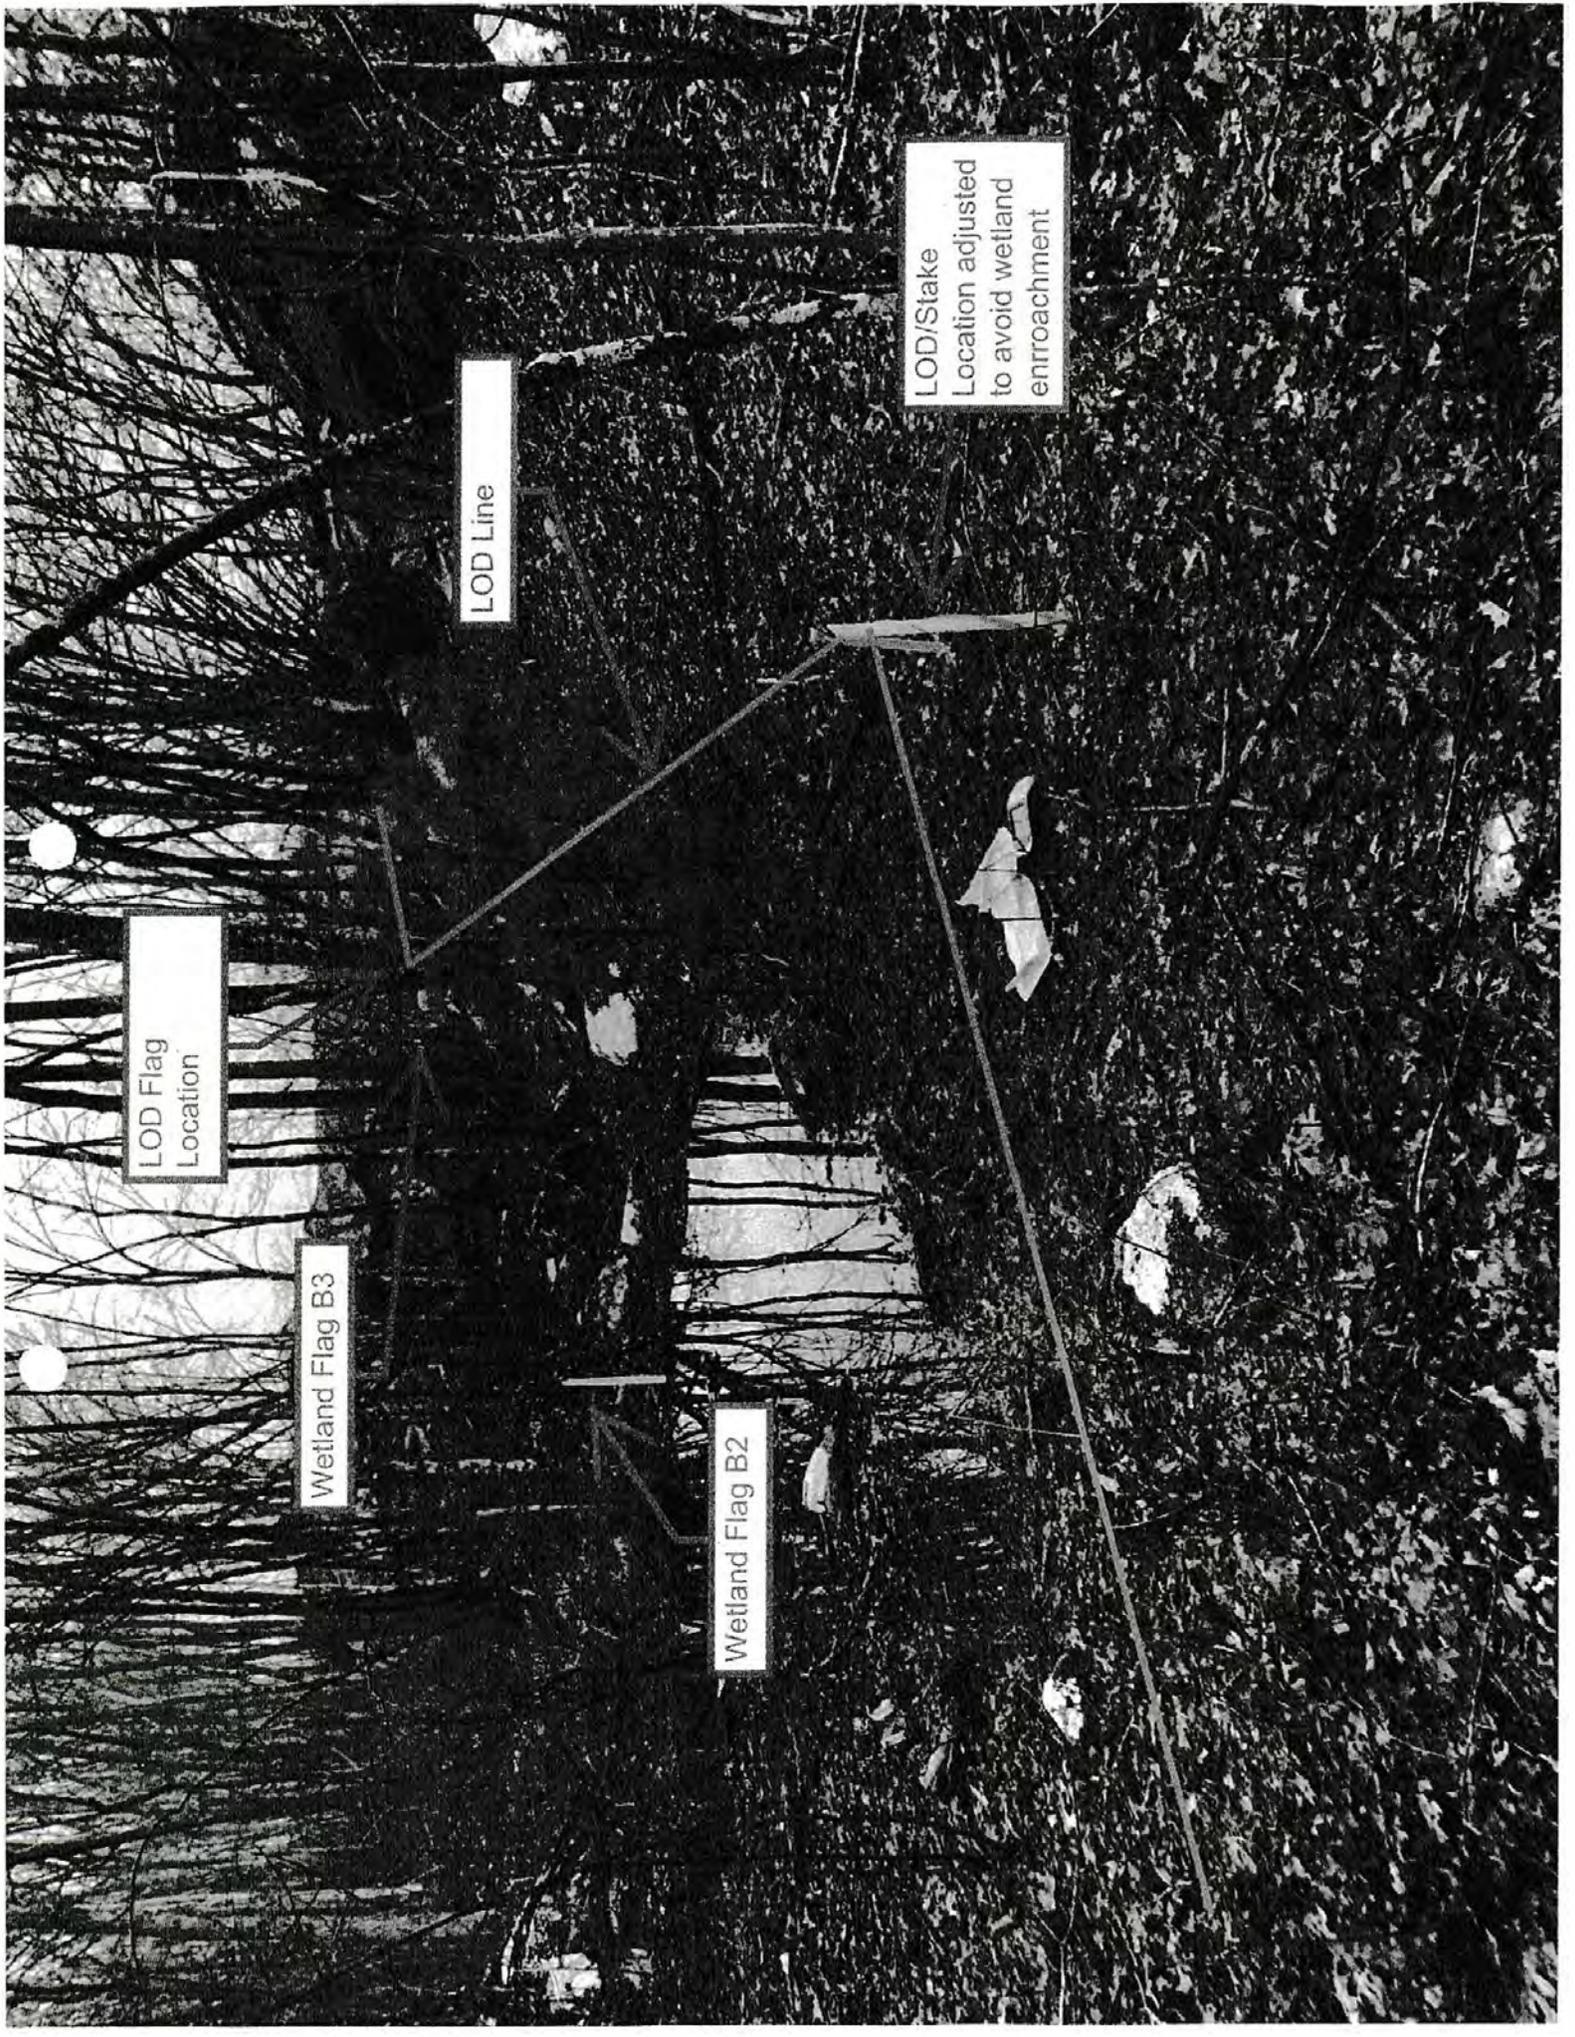
LOD/Stake
Location adjusted to avoid wetland encroachment

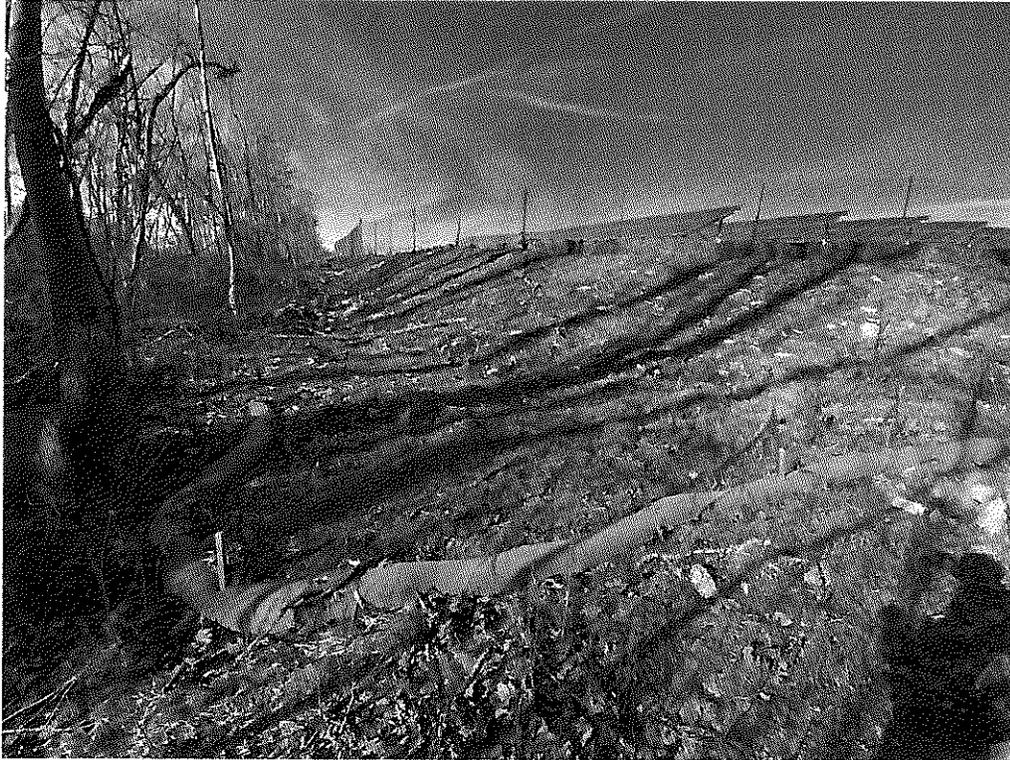
- I first inspected the southeast corner of the solar array adjacent to the off-site forested wetland with access from Newlight Street in West Warwick. Erosion controls could be bolstered in this area (see Photos 1 and 2). There is some evidence of overflow, although no sedimentation was observed in the offsite wetland. Braided flow paths are present in this wetland that extend down slope to another pocket of forested wetland. These wetlands are separated from Lippett Brook and associated swamp by landforms. Lippett Brook is flowing clear (Photo 3).

Photo 1: Condition of erosion controls in southeast corner of the solar array:

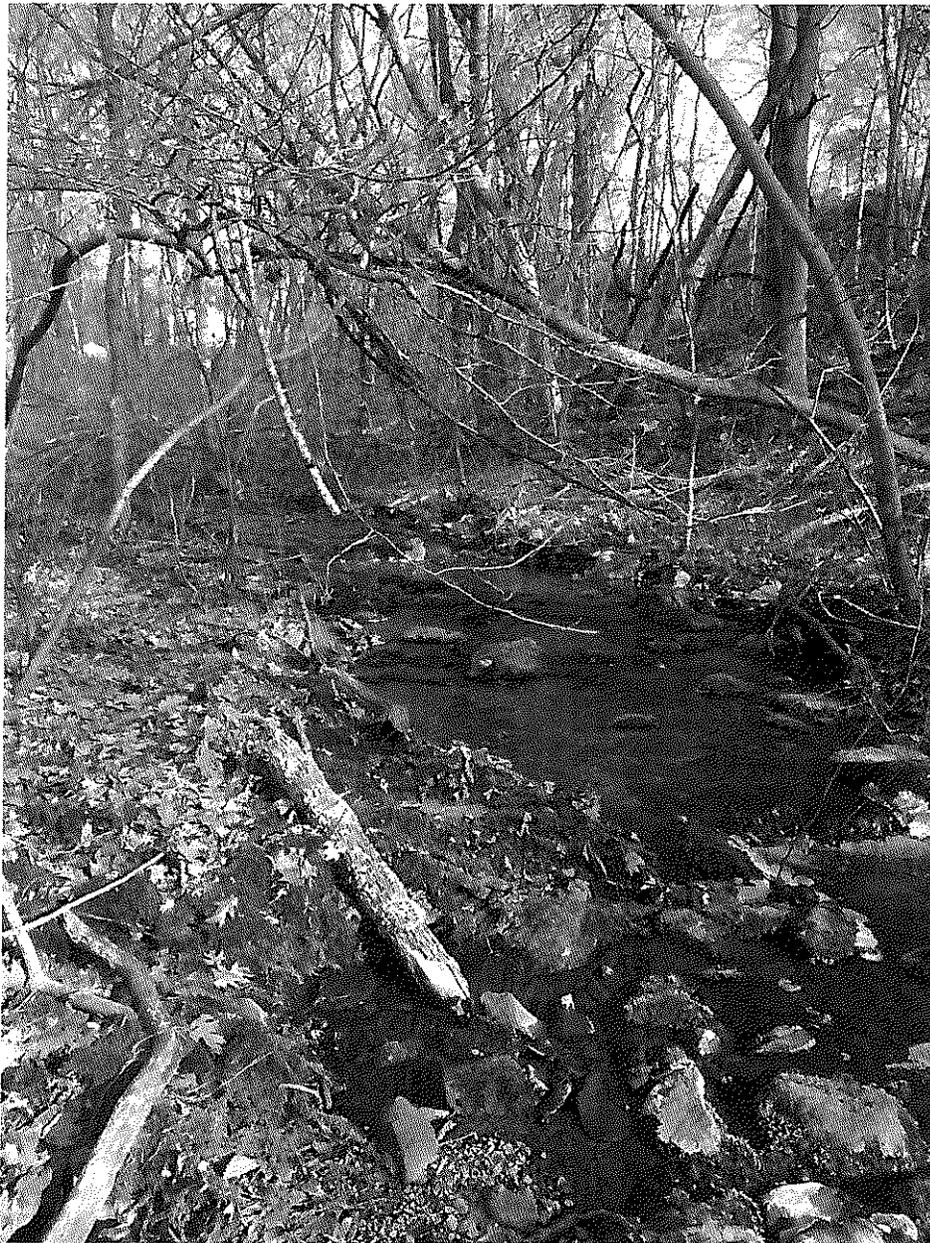
Photo 3: Lippett Brook running clear on-site 200+feet east of solar array:

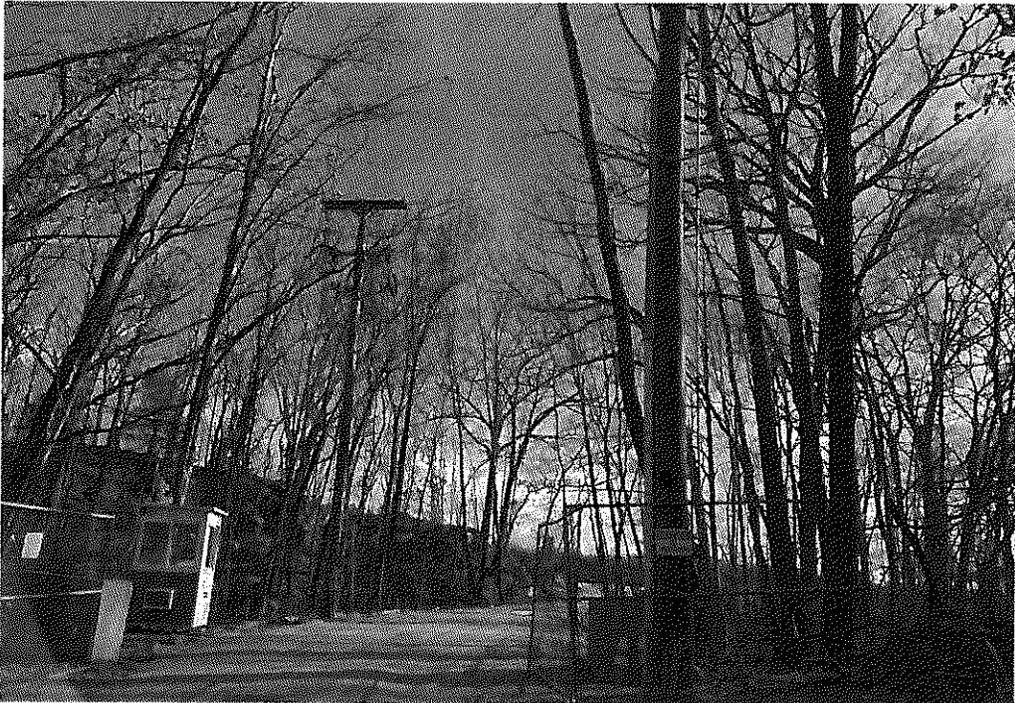
Photo 4: Entrance to solar array from Lippett Road access road-two new poles recently installed:

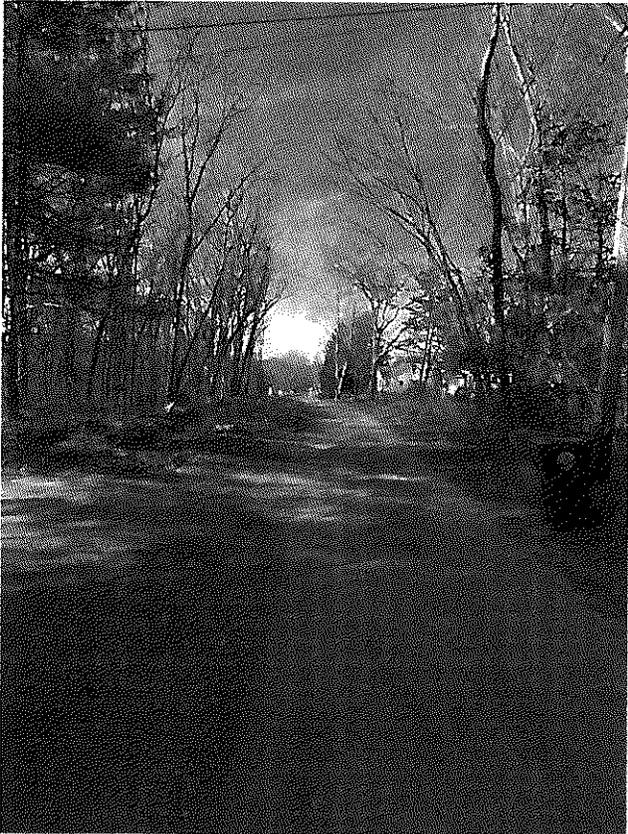
- The south side of the access road has been cleared (Photo 5). It should be noted that a vegetated wetland is present further down slope in the adjacent interior woodland south of road. It was also noted that the ASSF culverted underneath the access road was not flowing at the time of inspection.

Photo 5: recent clearing on south side of access road to solar array:

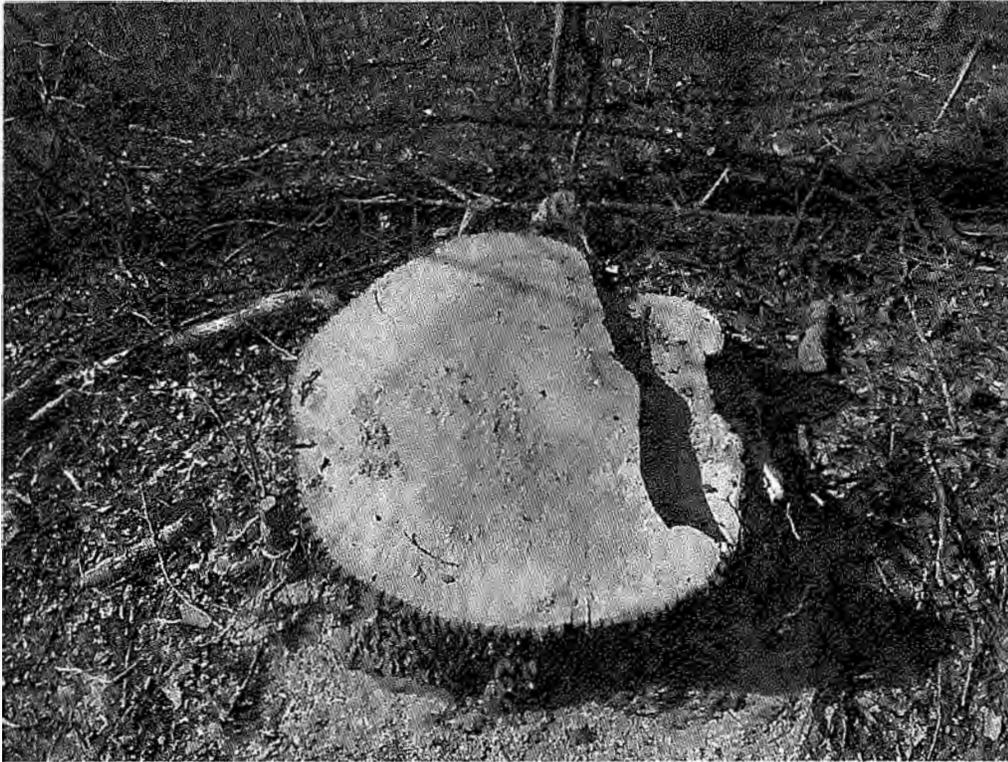
- I drove up Lippett Avenue. Several mature canopy trees have been recently taken down along the west side of the road with stumps remaining (Photo 6). Near the intersection with Hope Road, Blue Wetland Flags were observed within the woods west of the road. Clearing so far appears to be within upland based on windshield observations, but this was not confirmed by a site inspection on the ground.

Photo 6: Mature trees recently cleared on west side of Lippett Avenue:

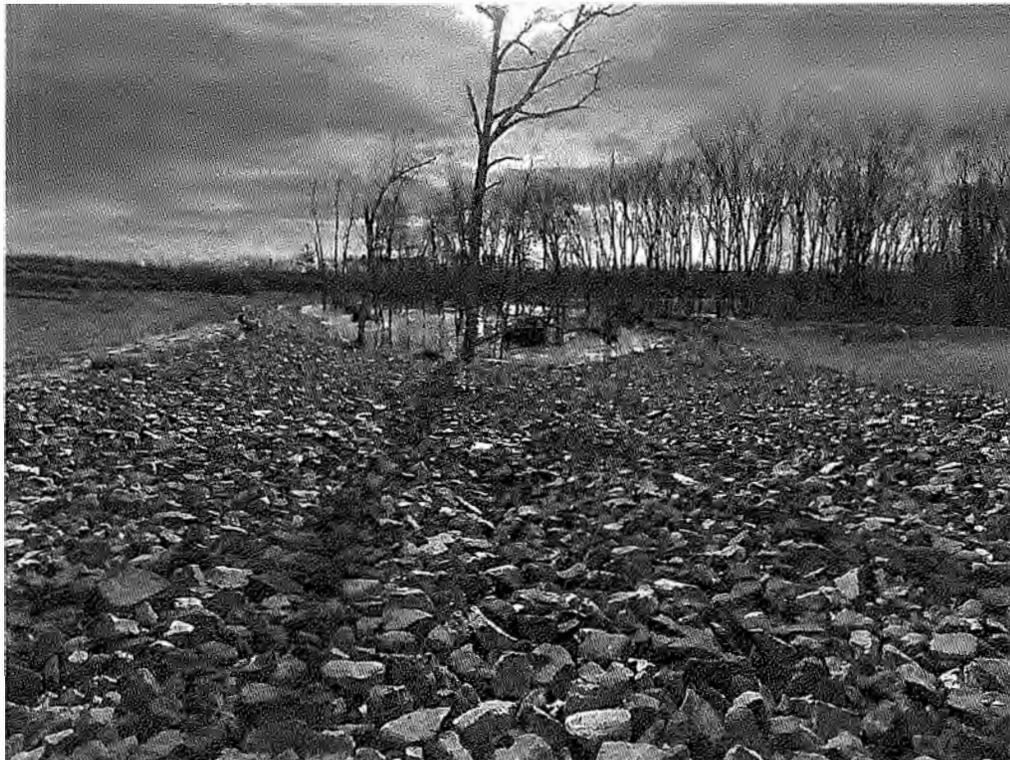
- I checked into the construction trailer to identify myself and signed in as requested. I walked to Wetlands C, E and F accompanied by Ray Gatto of Condi Corporation. Additional rip rap has been extended up slope from Wetland F to stabilize soils. Wetland F remains flooded, now well beyond its natural banks. Additional erosion controls measures (straw bales) have been installed, but still they are inadequate based on the site's topography and lack of vegetative cover. See-Photo Nos. 7,8,9 and 10. Although the wetland was frozen, you could see orange sediments at the very northern tip of wetland F.

Photo 7: Facing south over extended riprap towards flooded Forested Wetland F:

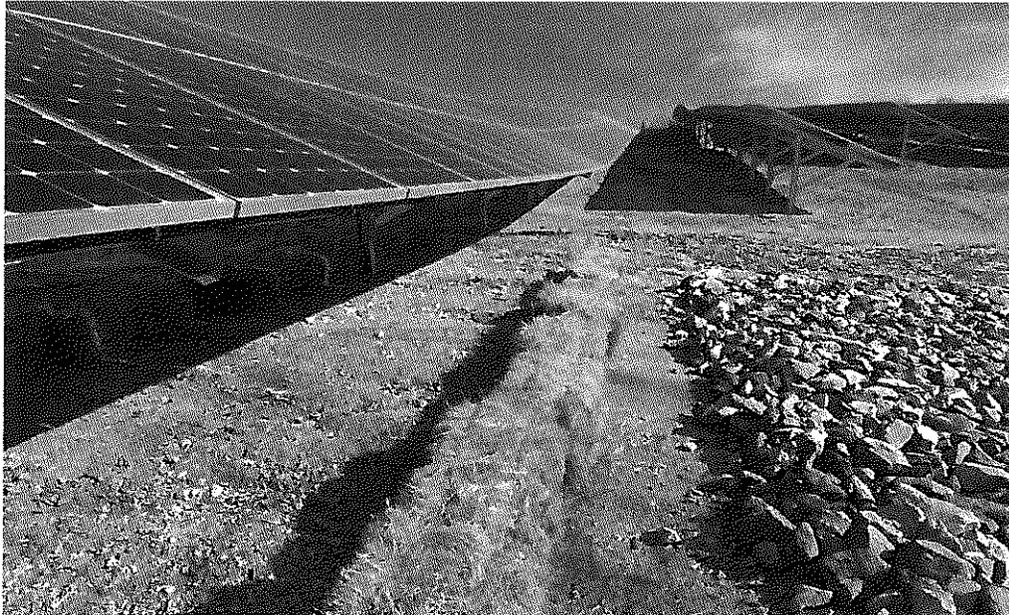
Photo 8: Top of riprap slope north of Wetland F with additional erosion control measures:

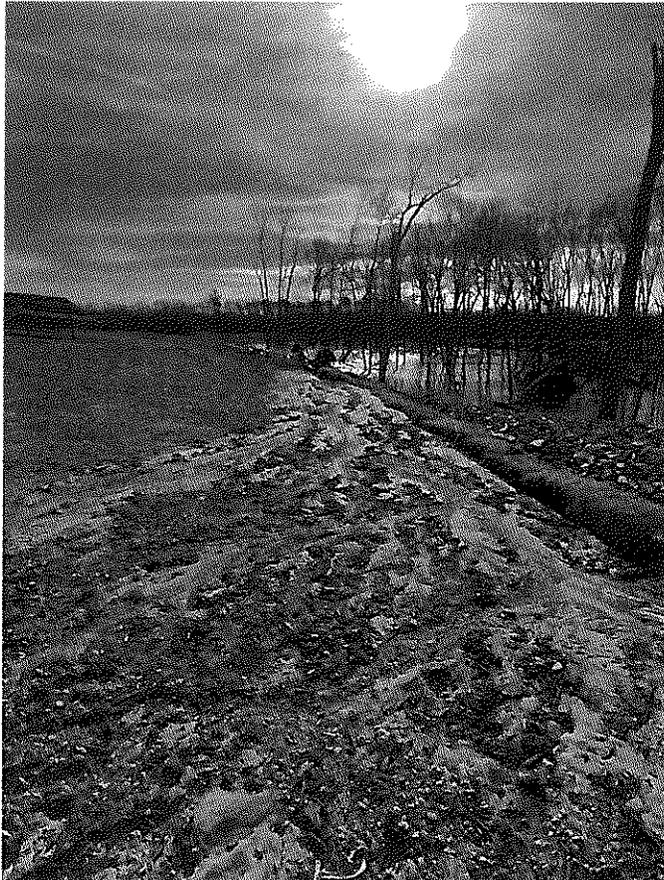
Photo 9: Eastern side of Wetland F, some new erosion control reinforcements:

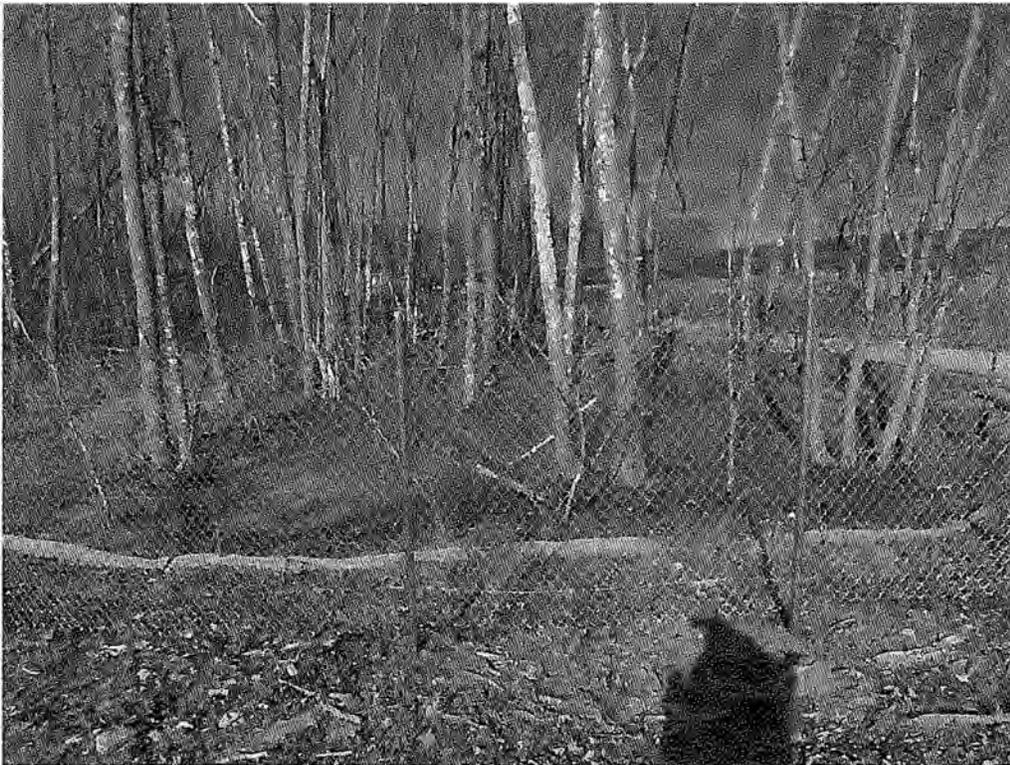
Photo 11: Facing North at Wetland E (fence between E and F is open on the bottom as suggested):

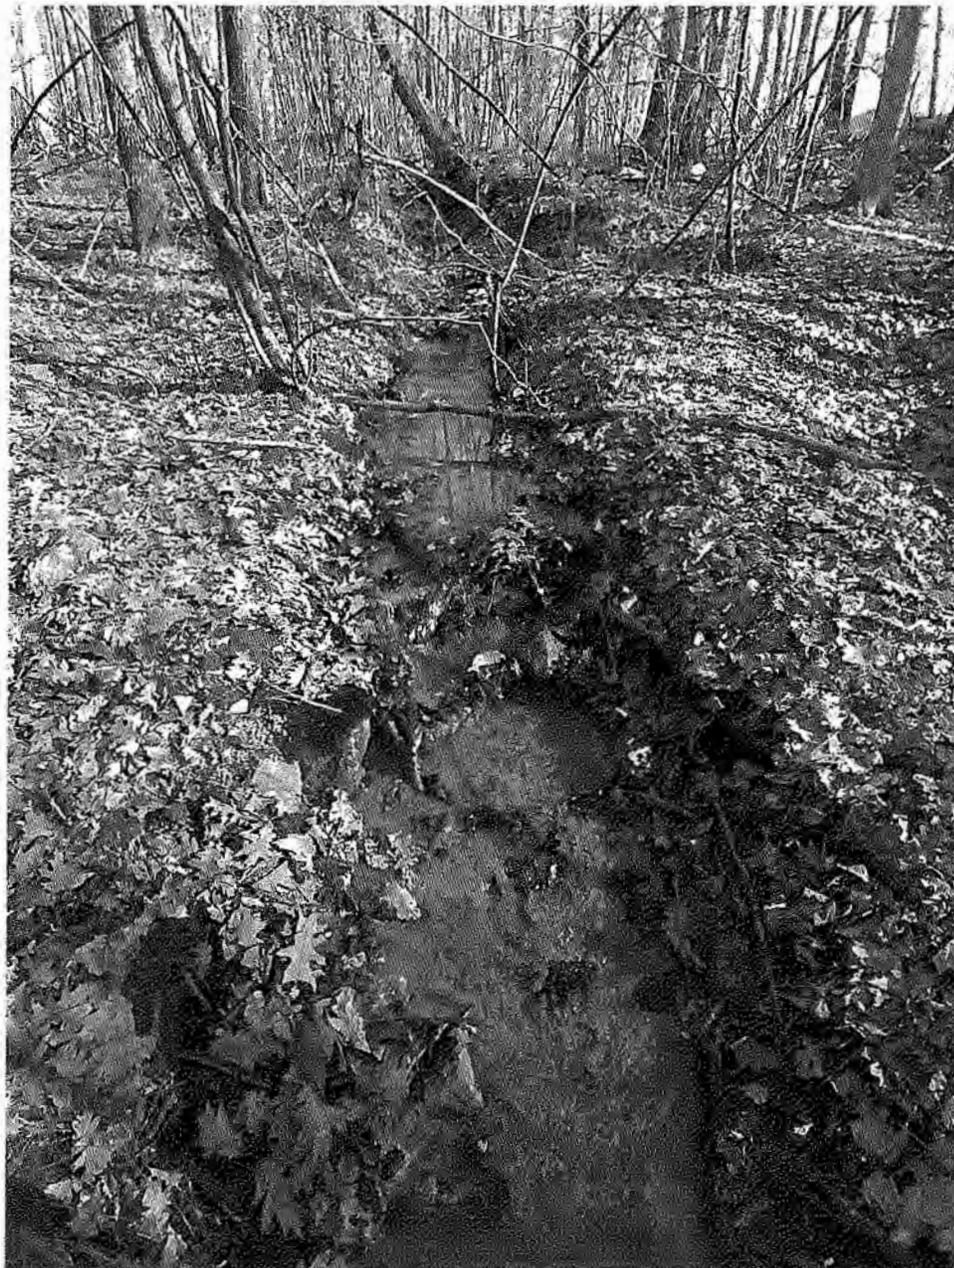
Photo 12: Swamp D stream channel downstream of Wetlands E and F remains orange from iron bacteria:

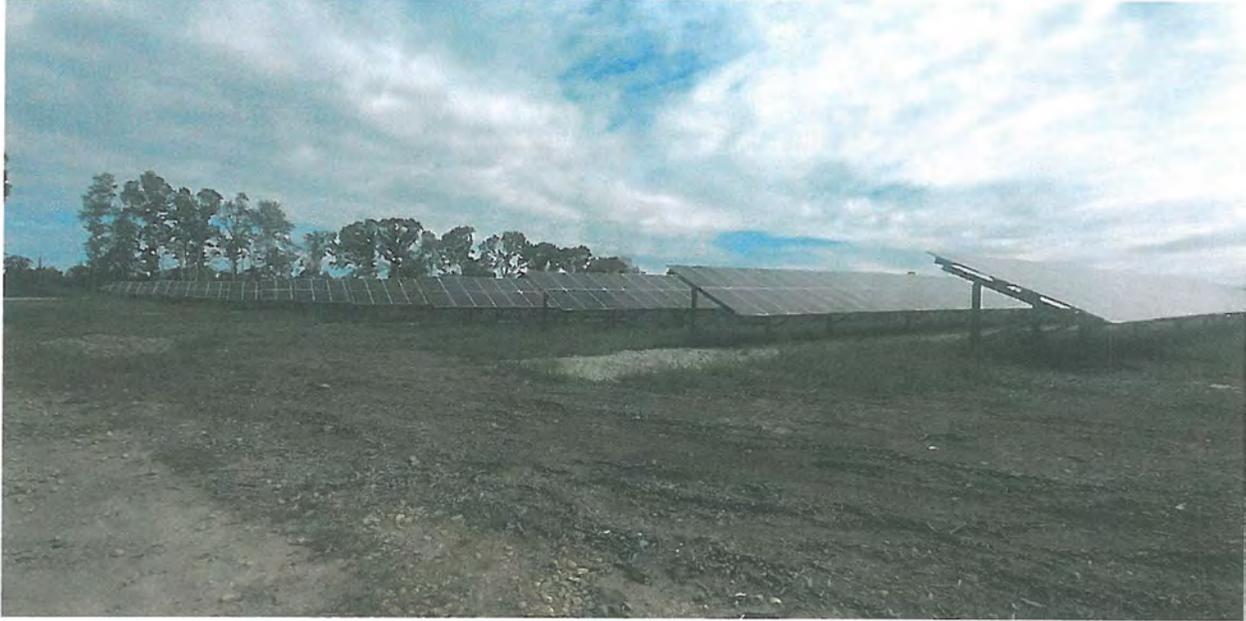
Northern portion of the site with some grass established

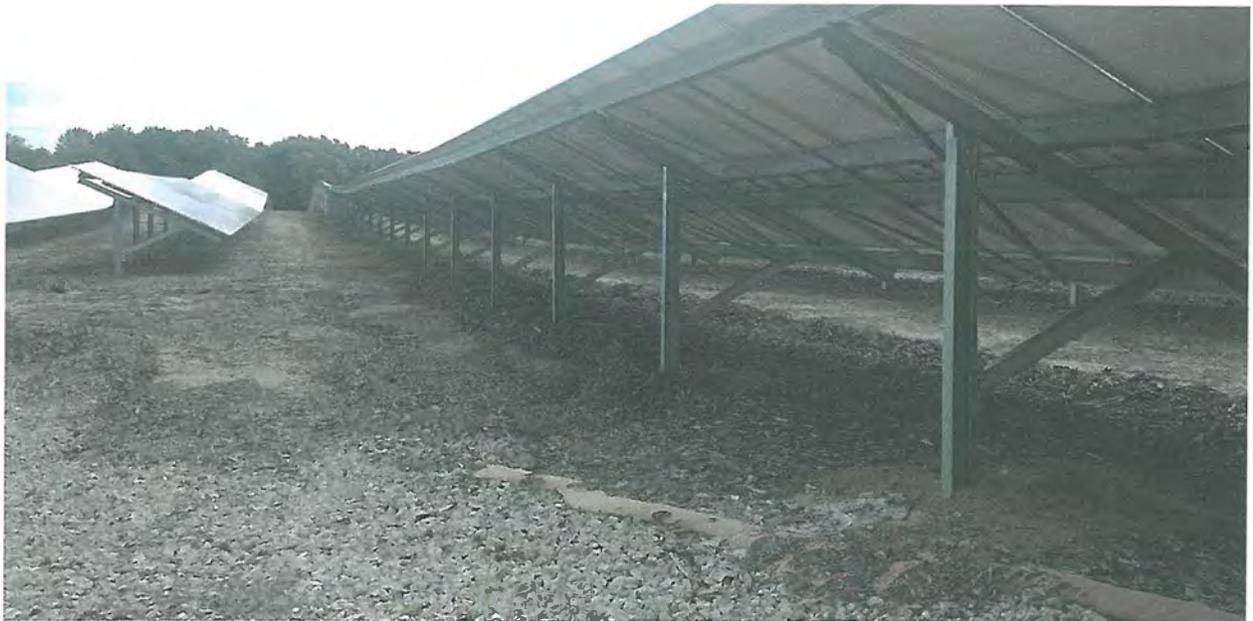
- The remaining approximately two-thirds of the site is not stabilized. Piles of mulch from winter stabilization measures remain present and there is little vegetation that has taken hold. This area is generally where ledge was blasted and there is not adequate topsoil and continues down slope to the south where topography is more conducive to runoff impacts. Per Brian McGovern, this area of the solar array is targeted to be re-seeded starting mid-September. These areas were previously hydroseeded, but grass burned out during a summer heat and dry spell. Dave Russo suggested that the mulch be raked prior to seeding.

Typical ground conditions observed on the southern 2/3rds of the site

This reviewer recommends follow-up from the RIPDES Program or OC & I to enforce the site stabilization measures that were permitted. I also recommend follow-up with Water Quality specialists at DEM and others to discuss the water quality and wetland impacts enumerated above.

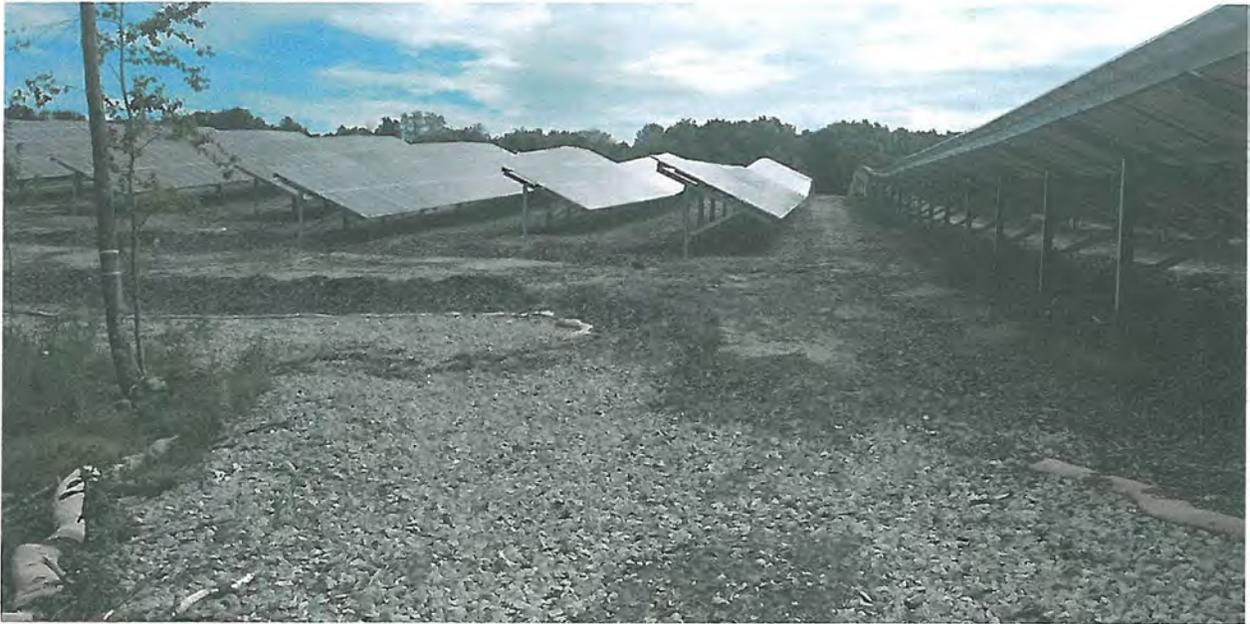
Soils barren, just east of terminus of Wetland F

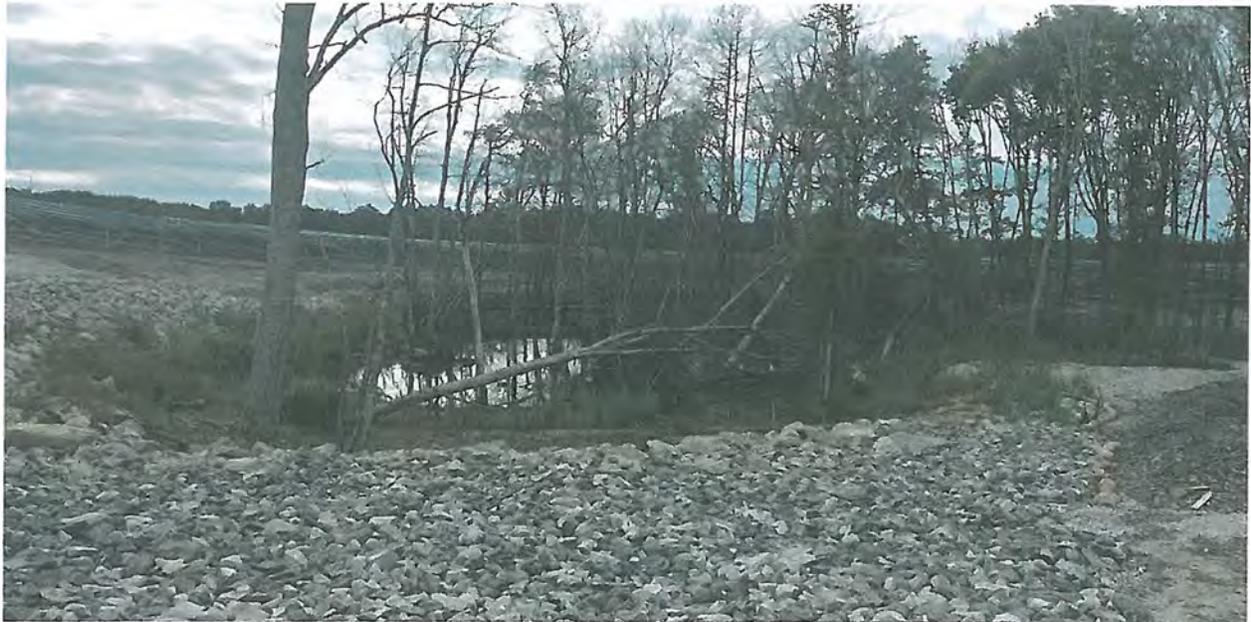
Wetland F facing southeast, trees dead during height of growing season

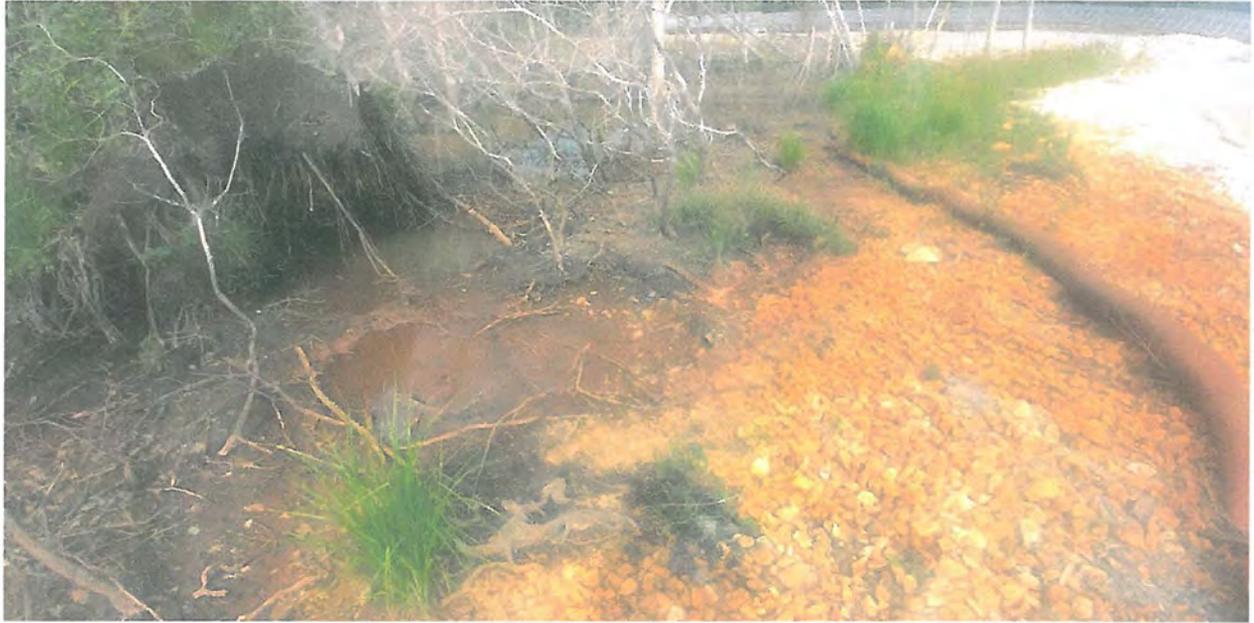
Wetland F Water Quality facing northwest, note stained rocks
