**R.I. DEPARTMENT OF ENVIRONMENTAL MANAGEMENT
OFFICE OF WATER RESOURCES PERMITTING SECTION
FRESHWATER WETLANDS PROGRAM
APPLICATION INSPECTION REPORT**

Application No.: 16-0202 **Applicant Name:** DSM Realty Corporation

SITE INSPECTION REPORT

File Name: DSM Realty Corp (Gold Meadow Farms Solar Array Project)

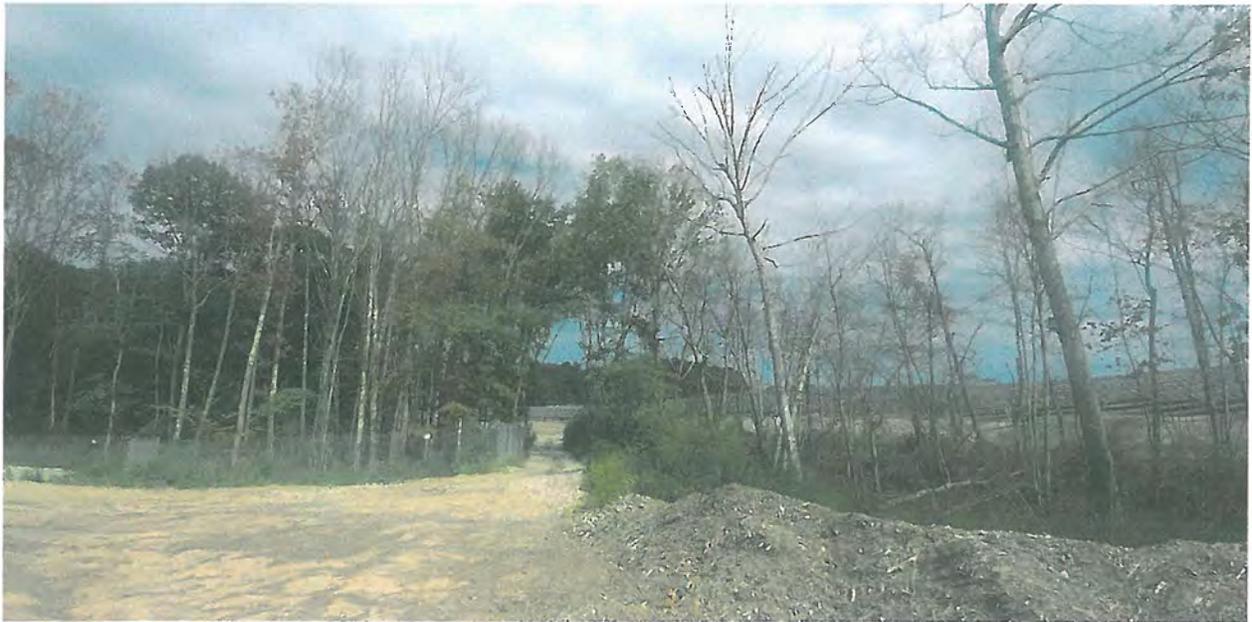
Wetland E to the left and Wetland F to the right facing north. Note: trees starting to die in Wetland E

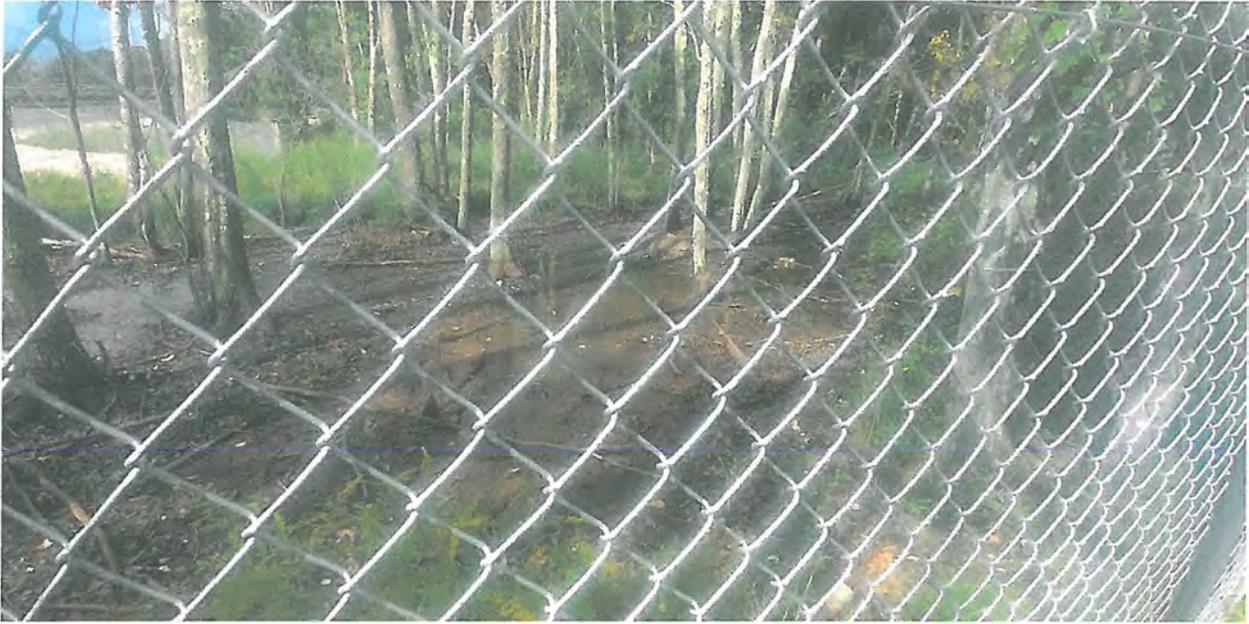
Wetland E facing westerly, water levels receding
