Donald Price Medium Security Facility
20 Goddard Drive
Cranston
Providence County
Rhode Island

RIHRA No. CRNS-0009

RHODE ISLAND HISTORICAL RESOURCES ARCHIVE
DONALD PRICE MEDIUM SECURITY FACILITY
(FORMERLY THE STATE REFORMATORY FOR MEN)
RIHRA No. CRNS-0009

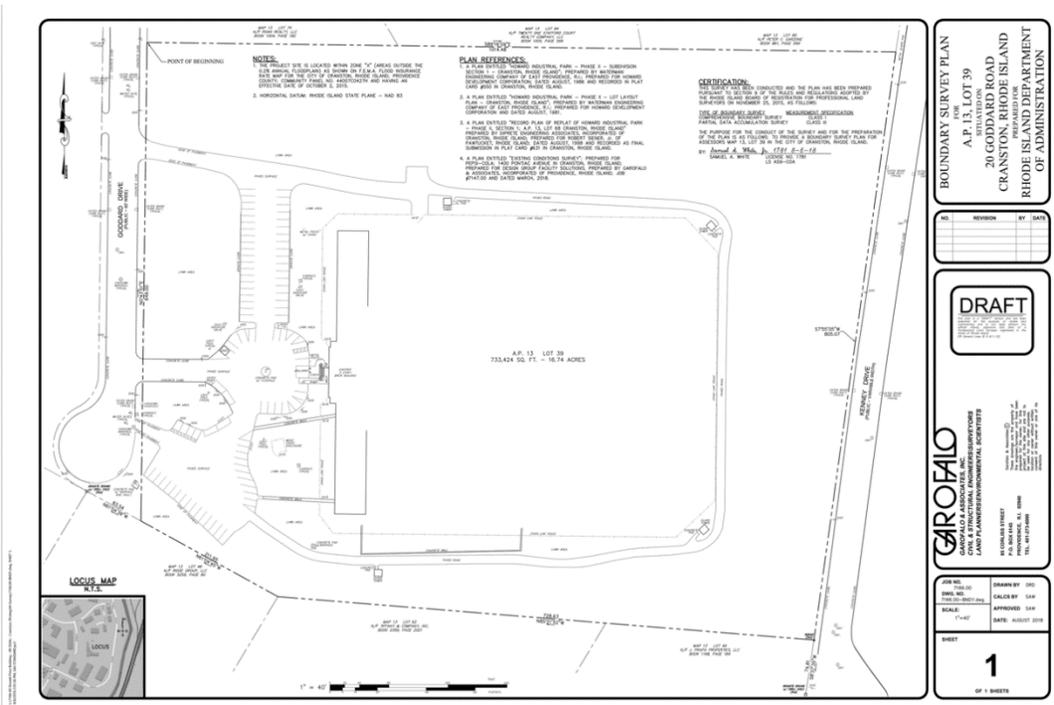
Site Survey (Draft) by Garofalo and Associates (2018)

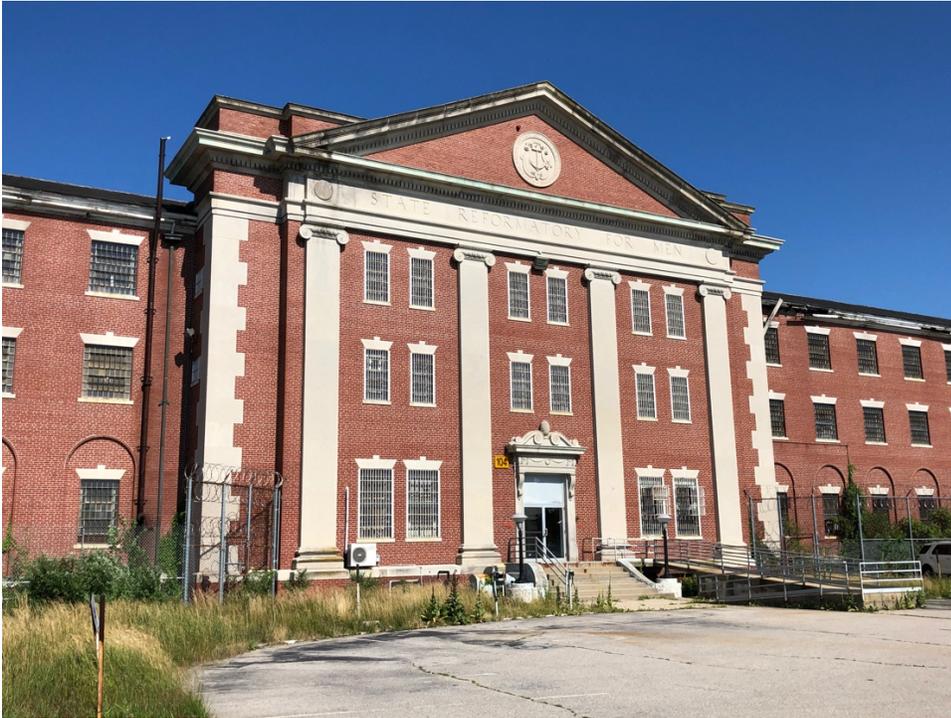
CRNS-0009-1 West Façade of Central Pavilion Looking East

The main entrance façade of the central pavilion exhibits a monumental neo-classical composition of four flat Ionic pilasters supporting an entablature inscribed with the words “STATE REFORMATORY FOR MEN” in its fascia. Within the triangular pediment above, the circular limestone State Seal carved in relief is set in a field of red brick. Between the pilasters, the brick field is punched with pairs of rectangular multi-pane steel-framed windows at each floor, fitted with steel security bars.

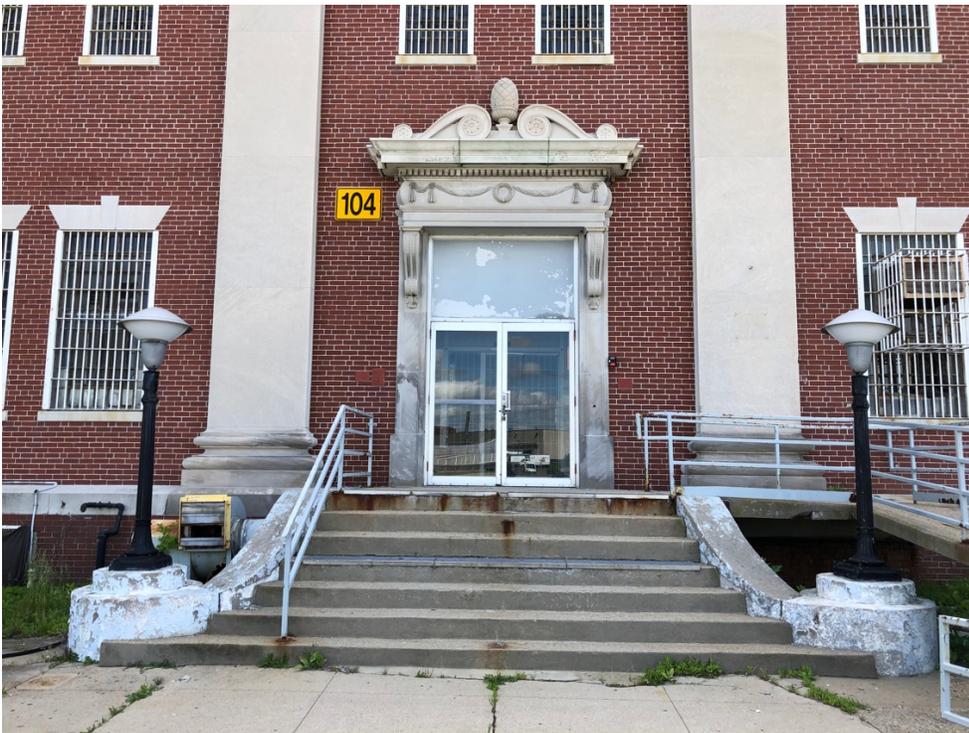
CRNS-0009-2 Main Entrance, West Side

The main entrance in the center of the façade features a handsome ornate limestone portal with intricately carved brackets, swags on a convex frieze, and a pine cone atop the cornice flanked by scrolls. The incongruous aluminum storefront entrance is a later alteration, probably undertaken at the same time that a concrete ramp with steel pipe railing was introduced. The broad concrete staircase leading up to the main entrance is framed by low curved walls terminating in a raised circular base for modern light stanchions. (The original 1931 plans called for curved “granite steps and limestone buttresses” similar in plan to the current configuration.)

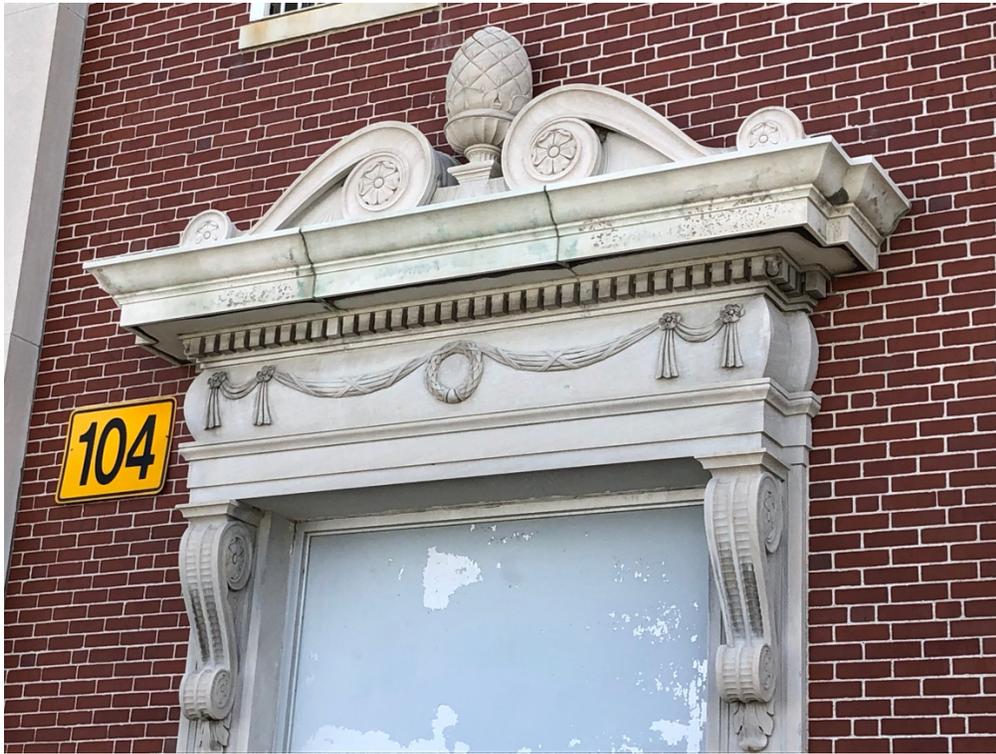
CRNS-0009-3 Limestone Portal at Main Entrance

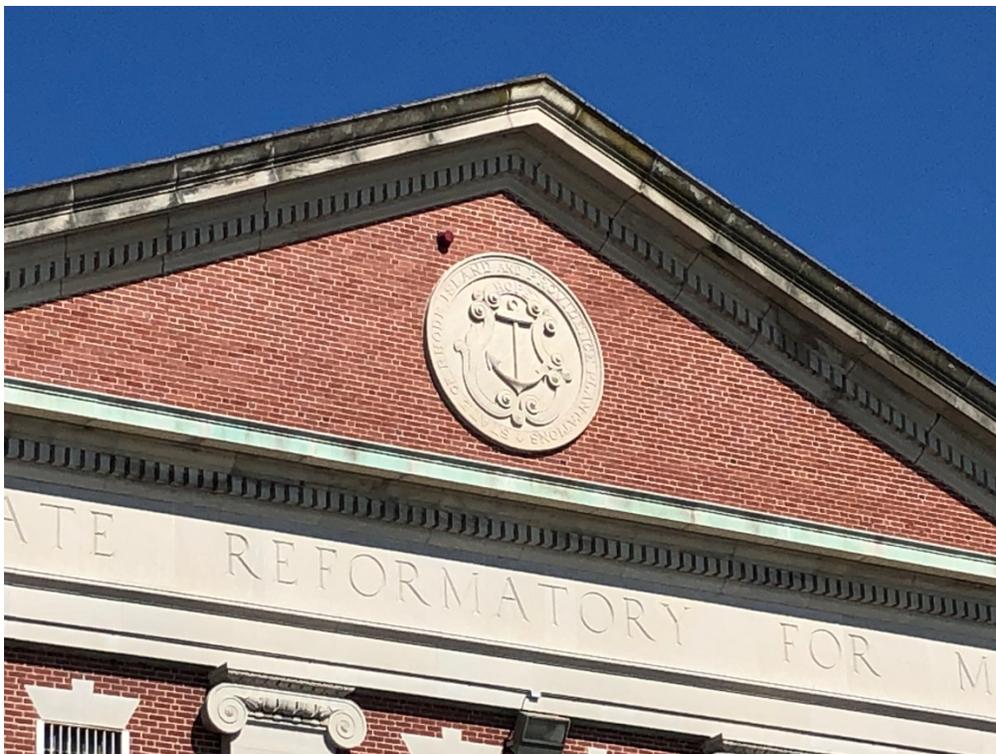
CRNS-0009-4 State Seal in Pediment of Pavilion, West Side

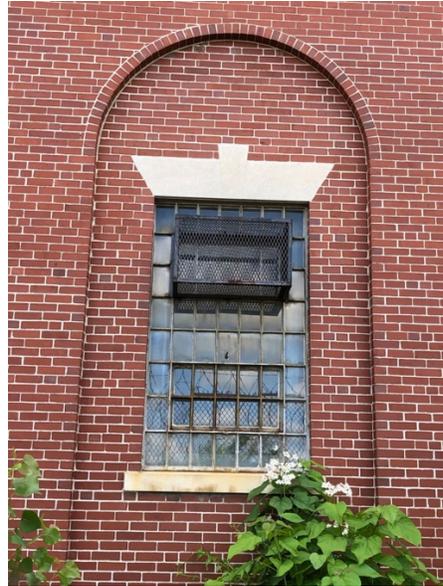
CRNS-0009-5 Typical First Floor Window

The exterior is clad with common red brick with splayed limestone lintels and projecting sills at most of the windows. Brick veneer and limestone components were fully bonded to structural concrete block back-up. On the wings along the first floor level, the brick surface is set back to create a round arched recess at each window. Most of the windows are constructed of welded steel T-bars in a grid consisting of 56 panes of glass in the first floor windows and 63 glass panes in the upper floor windows. Each window was fitted with two in-swinging hopper panels for ventilation. Some of the

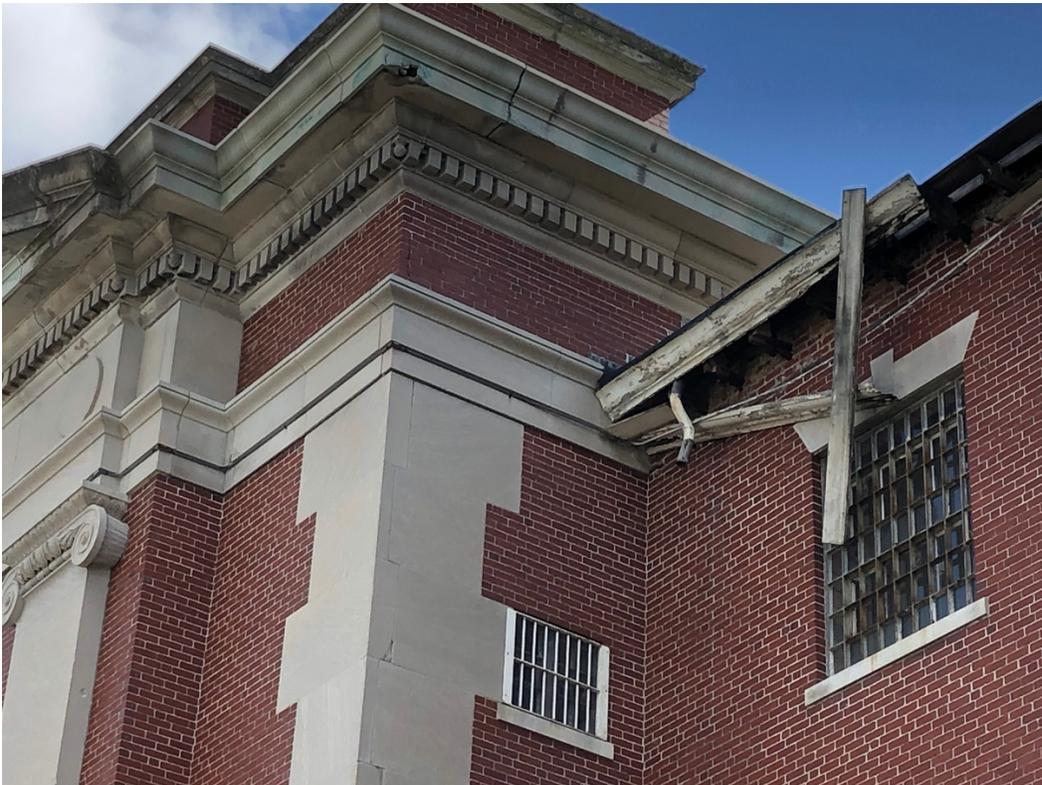
The wings are capped by hipped roofs with copper eyebrow vents facing north and south. The gable and hip roofs have a 5/12 slope and are covered with slate shingles in a state of disrepair. Glazed copper skylights were placed over the two exit stair towers on the east, flanking the central pavilion. A large skylight, no longer extant, provided daylight over the central staircase serving all five levels. Roof drainage was accommodated by built-in copper gutters and rain leaders with conductor heads. These are all in a state of disrepair, including the painted wood cornices supporting the gutters.

CRNS-0009-6 Detail of Southwest Corner of Pavilion. Note damage to gutter and main cornice.

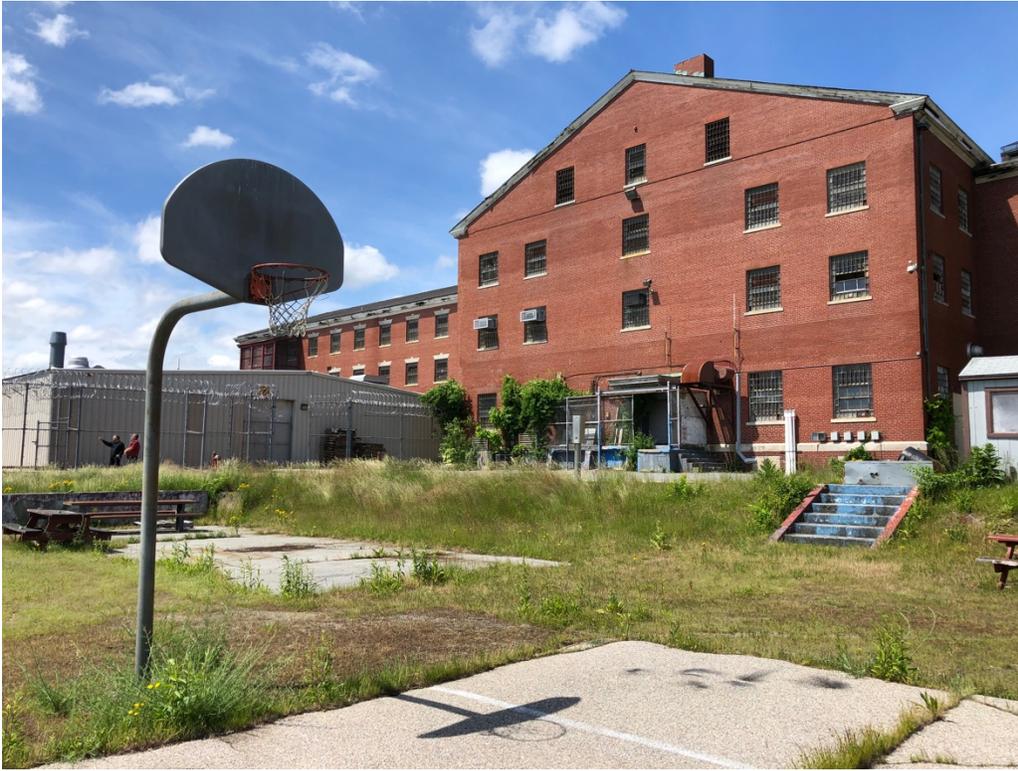
At the rear or east elevation of the wings, the fenestration retains the general opening characteristics of the west side of the building with recessed round arches on the first floor and limestone lintels and sills.

CRNS-0009-7 View of East Façade from Exercise Yard

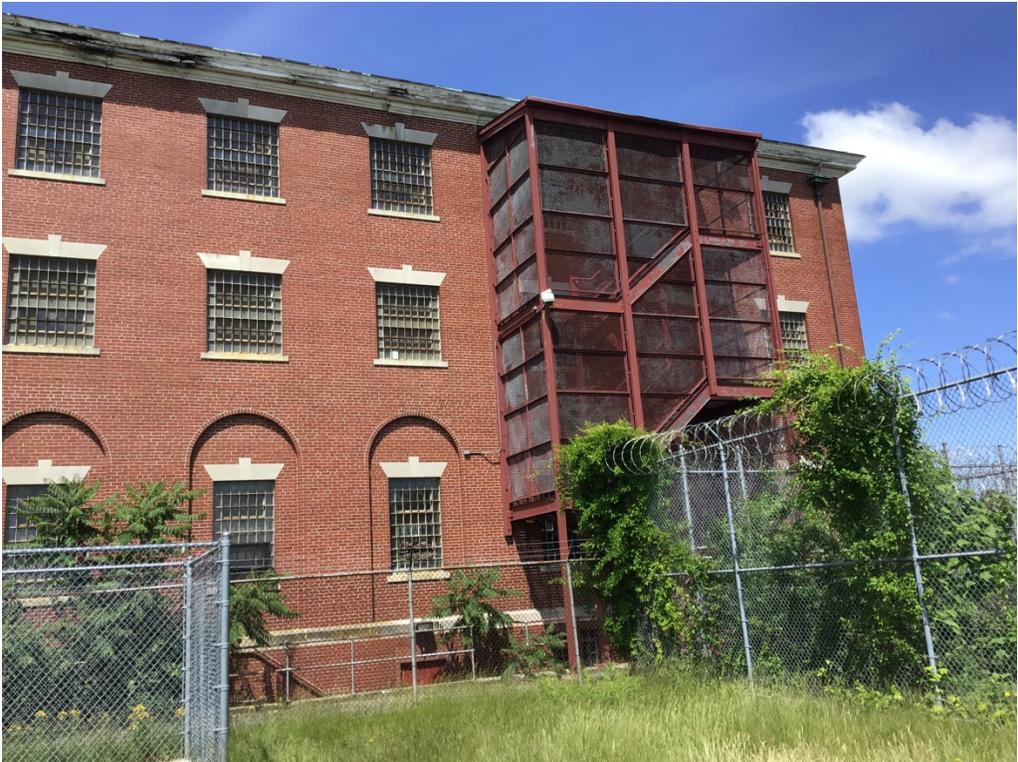
Exterior steel stairs enclosed with metal screening were constructed on the east side (as later additions), one bay in from

the north and south ends of the building to provide emergency egress from each level. Date of construction of these fire escapes is unknown.

CRNS-0009-8 View of Fire Escape on East Side, North Wing

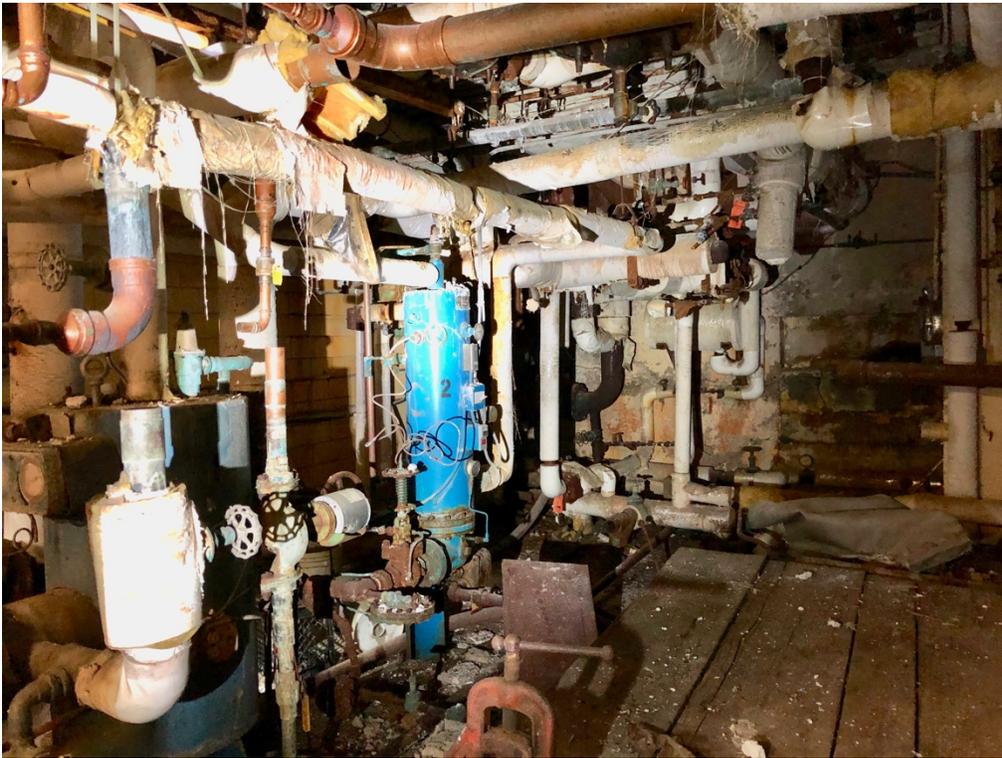
The steam heating system is serviced by underground steam pipes from the central heating plant in the Pastore Center complex hundreds of yards to the west and entering the building in the

basement (under the main entrance). Cast iron radiators were installed in recesses below the windows, fed by steam pipes embedded in the walls and floors. Condensate piping was installed in an exposed manner sometime later when repairs and alterations were made.

CRNS-0009-11 Boiler Room, Basement, Center Block

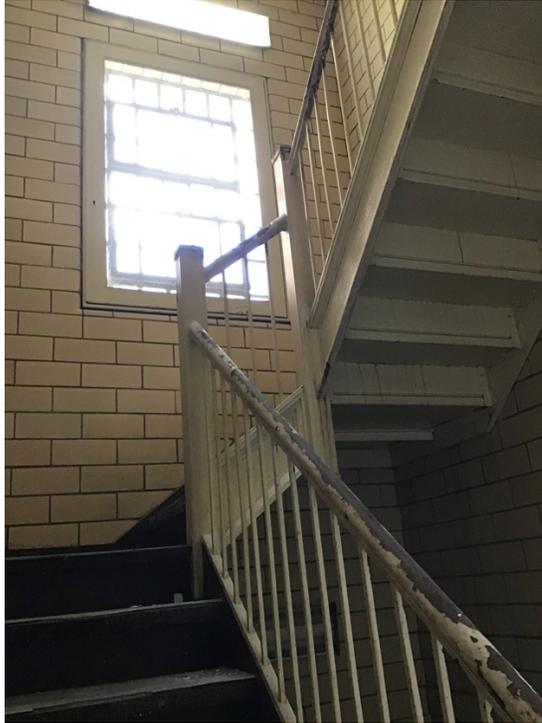
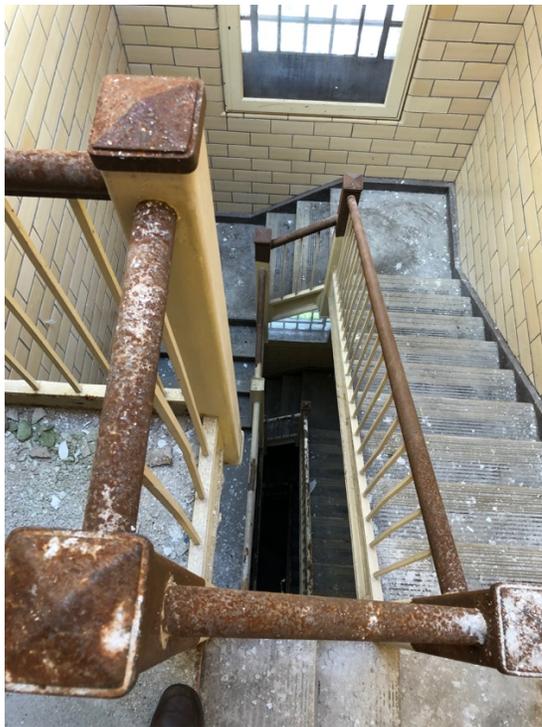
Most of the rooms were finished with durable, washable materials, with glazed tile walls, 'cement' floors, flat plaster ceilings, and linoleum flooring in certain spaces. There is no notable decorative treatment in any of the spaces. The three stair halls, lined with glazed tile walls, have steel-framed flights of stairs with simple steel balusters and newel posts and concrete treads and landings. Doors are mostly flush Kalamein (solid wood with metal cladding) and steel security doors and gates with hollow metal frames and obscure glass panels.

CRNS-0009-15 SE Stair Hall

CRNS-0009-16 SE Stair Hall

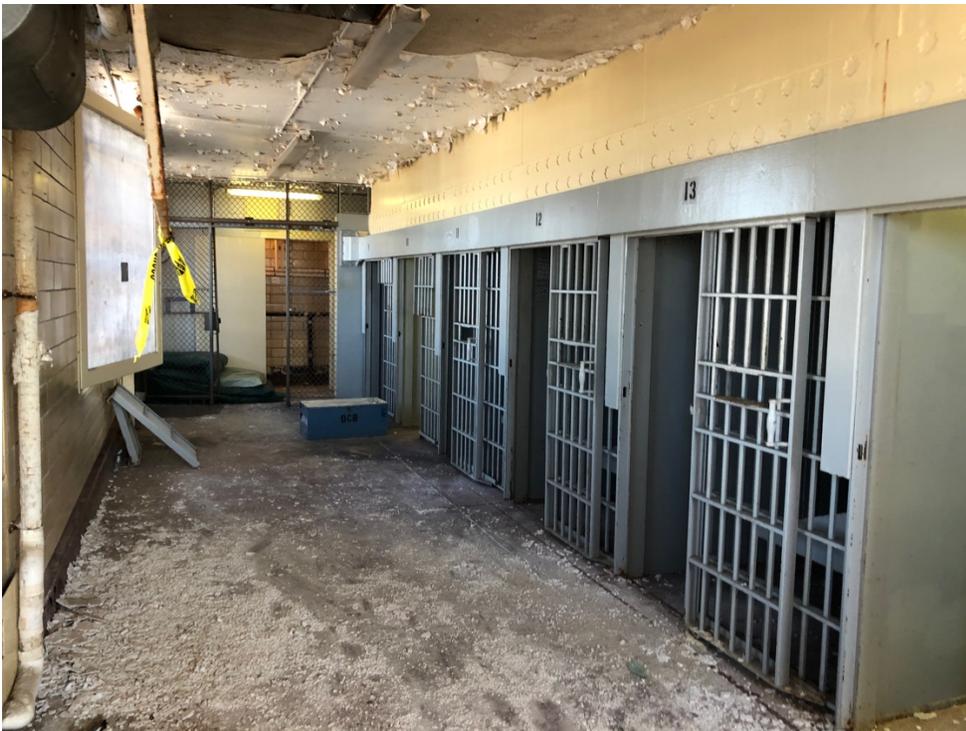
On the second floor, the center block included a library/school room, an occupational room, private offices for a psychologist and a psychiatrist, a large communal toilet room, and storage rooms. The north wing was a dormitory with a 'Day Room'. The south wing was split into two sections divided by toilet facilities. The room nearest the center block had 48 cubicles. The room at the far end of the south wing had 16 cells with a utility corridor dividing them.

CRNS-0009-20 Cells, Second Floor, South Wing (East Side), Looking South

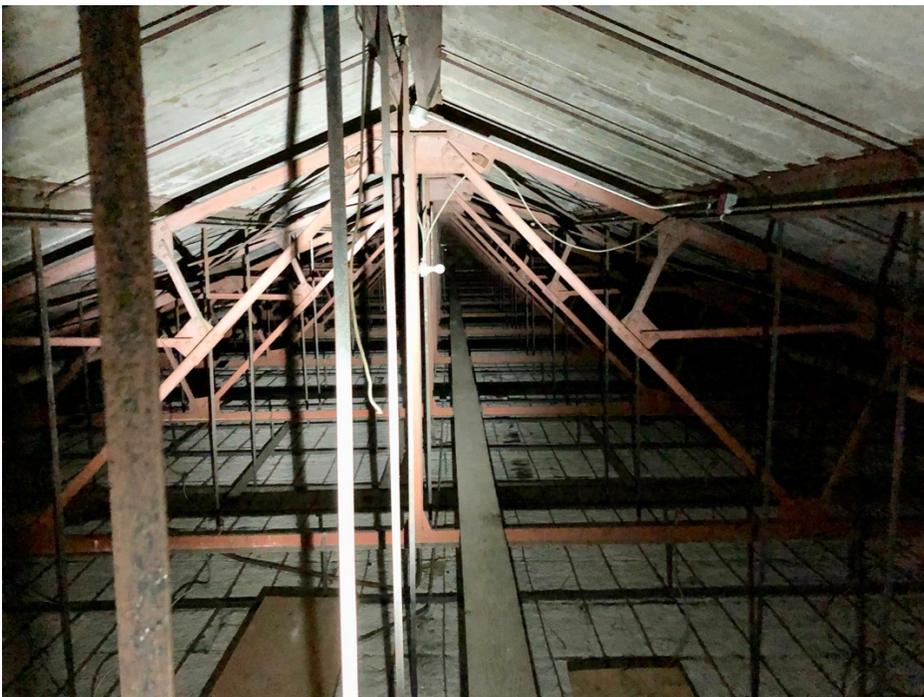
The entire building is of non-combustible, fire-proof construction, with concrete footings, foundation walls, floor slabs, and roof slabs, structurally framed in wide-flange steel beams and columns with clear span steel roof trusses at 12 feet on center over the wings. Steel columns were concealed in solid masonry walls. Steel beams were encased with three-coat plaster and metal lath. The building envelope is devoid of any insulation.

CRNS-0009-24 Attic, North Wing, Looking North

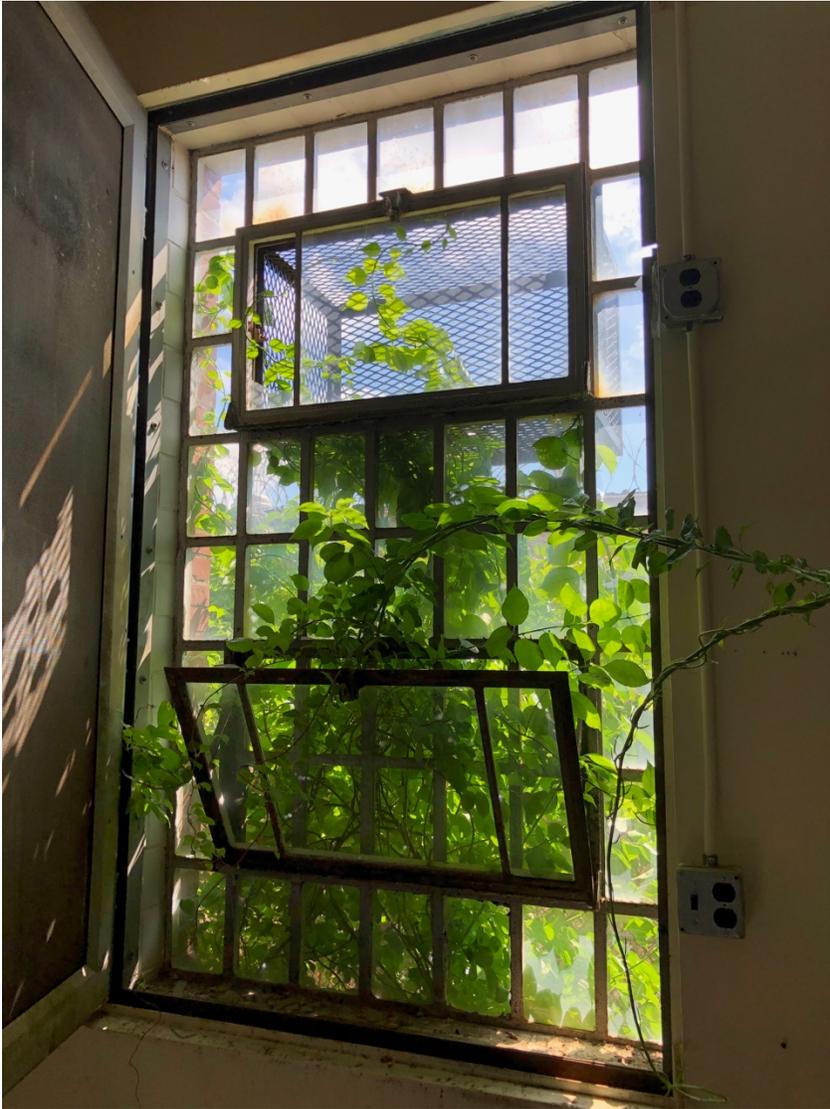
CRNS-0009-25 Typical First Floor Window

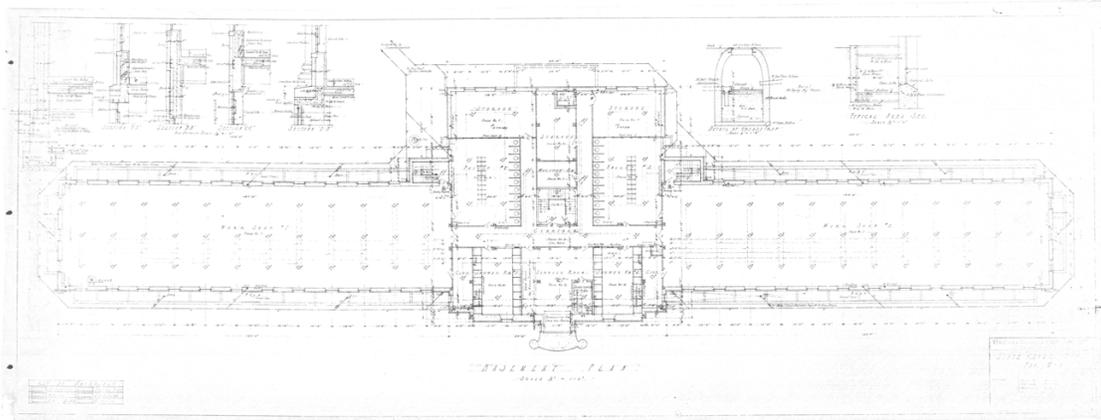
Basement Floor Plan

On the basement or lower level, the central core of the building provided utility rooms, toilet and shower rooms, three stair halls, storage rooms, and an elevator to the kitchen above. The north and south wings were designated as workshops.

Since 1933, the building has been adapted to functioning as a medium security prison until 2011, when it was closed. Major changes included the conversion of the workshops in the basement into a dormitory and a cluster of individual cells, and the elimination of the stage and subdivision of the north wing on the first floor for multiple purposes.

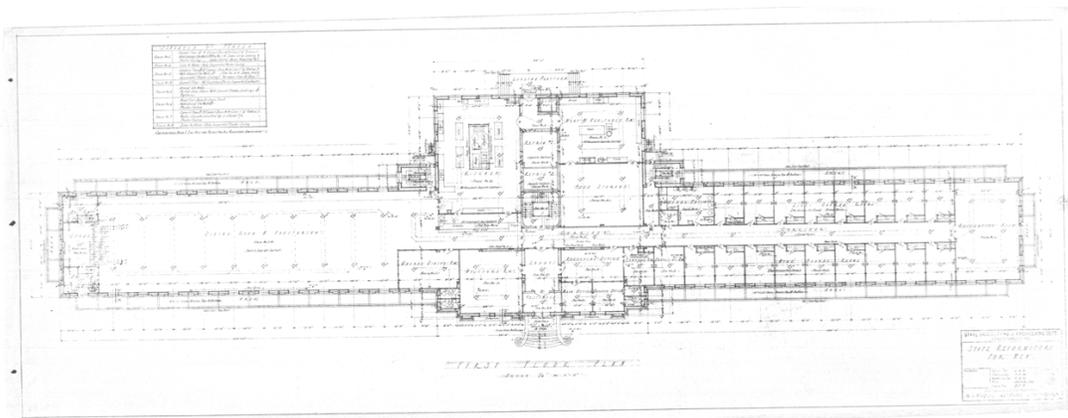
First Floor Plan

On the main or first floor level, the center block housed the main entrance lobby, offices, a lawyer's room, a chaplain's room, a visitor's room, a commercial-grade kitchen, food storage rooms, and a guards' dining room. The long open space of the north wing terminating with a raised stage flanked by dressing rooms provided

entertainment and daily dining for detainees. The south wing was partitioned into 17 guard rooms (with a common toilet facility) and a recreation room at the far end.

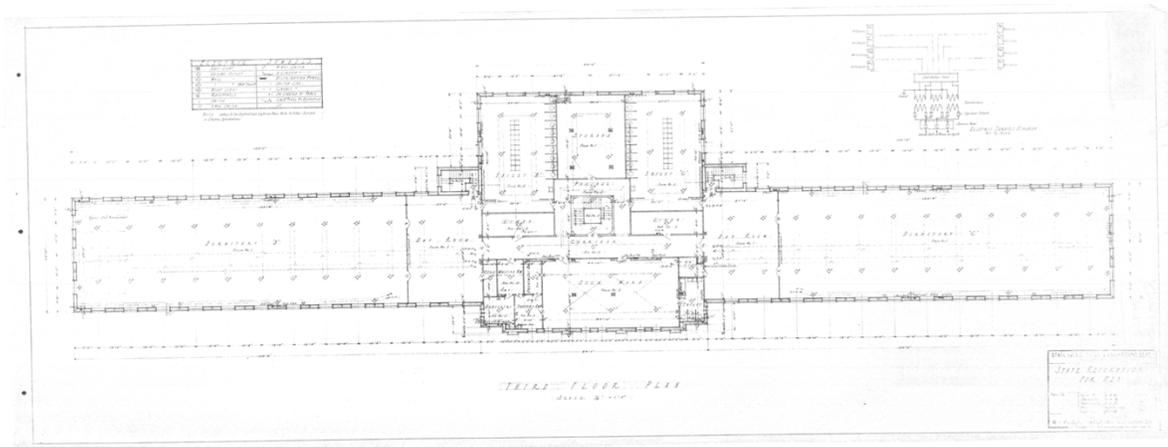
Third Floor Plan

On the third floor, the center block included a sick ward, a doctor's room, dentistry, a treatment room, and two large communal toilet rooms. Both wings were used as dormitories with day rooms.
