Re: 2023 Annual Report
RIPDES Permit NO. RIR040012, Cranston, RI

Enclosed please find the City of Cranston's Phase II Storm Water Annual Report for Year 20. This report documents implementation of the City's Storm Water Management Program Plan (SWMPP), TMDL Implementation Plan, and State requirements pertaining to the discharge of stormwater.

RIPDES SMALL MS4 ANNUAL REPORT
GENERAL INFORMATION PAGE

RIPDES PERMIT #RIR040012

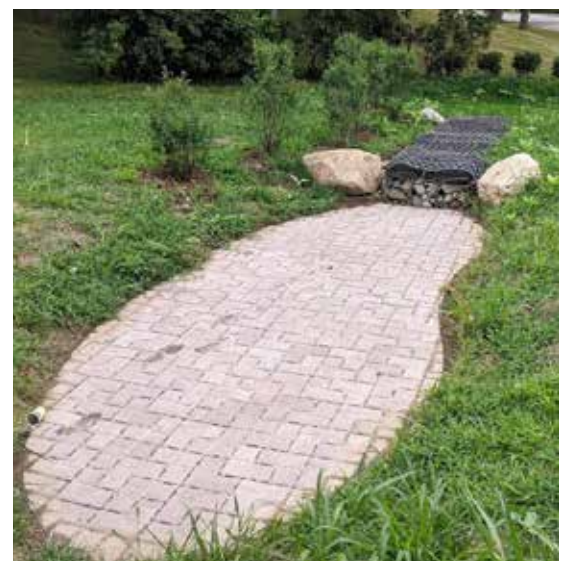
What appear to be patios are actually pathways of permeable pavement that direct stormwater to a containment area to remove sediment. The water then travels on to natural filtration zones to decontaminate the roadway runoff while it seeps into the water table.

But they're not patios at all. Instead, they are pathways of permeable pavement that direct stormwater to a containment area to remove sediment. The water then travels on to natural filtration zones to decontaminate the roadway runoff while it seeps into the water table. They are among 42 installations constructed throughout the park and used by the Providence Stormwater Innovation Center, where green infrastructure is helping to improve water quality in the park's ponds while demonstrating nature-based solutions to one of the leading causes of water pollution in the state.

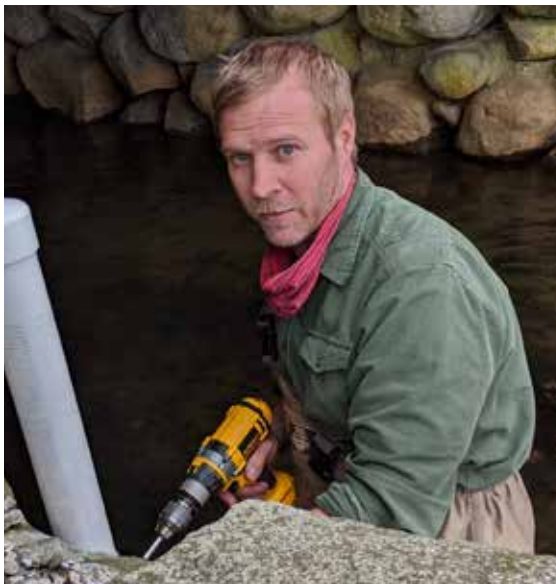
Audubon Stormwater Coordinator Ryan Kopp installs water monitoring equipment at Roger Williams Park.

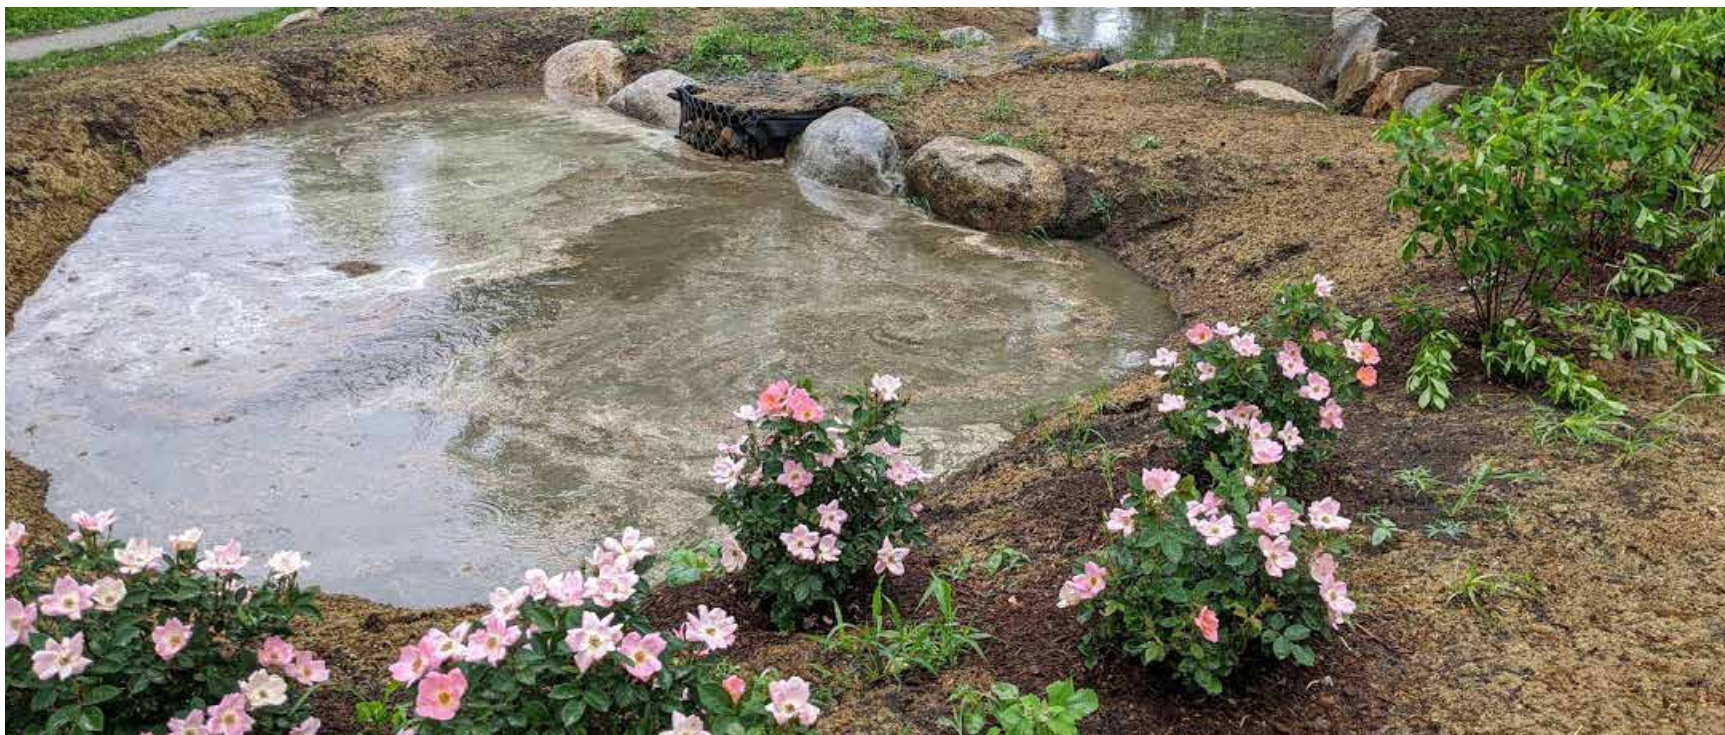
This infiltration basin, built in 2019, is designed to reduce phosphorous loads by 11.6 lbs/year rather than being discharged directly to the ponds at Roger Williams Park.

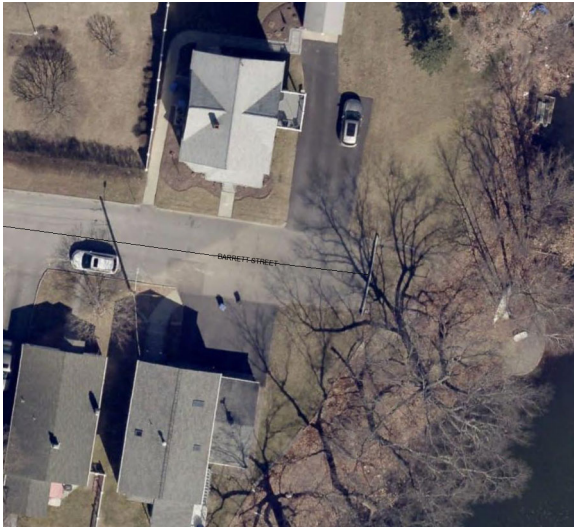
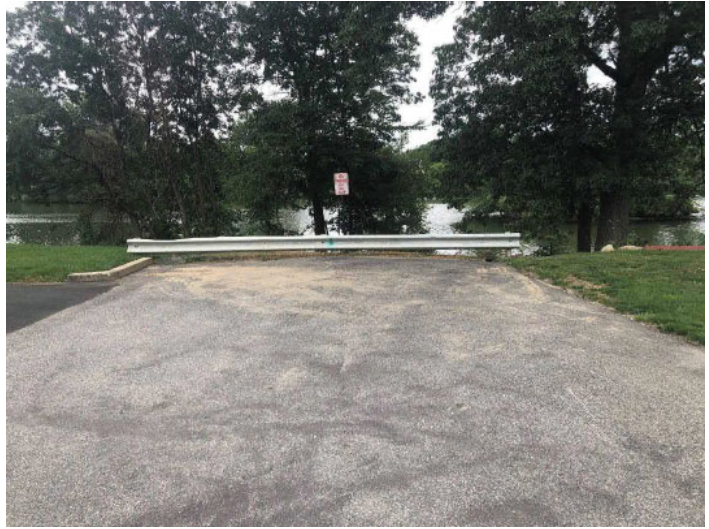
Test pits were dug at the end of Winthrop Street and Barrett Street by Cranston DPW staff.
