**R.I. DEPARTMENT OF ENVIRONMENTAL MANAGEMENT
OFFICE OF WATER RESOURCES PERMITTING SECTION
FRESHWATER WETLANDS PROGRAM
APPLICATION INSPECTION REPORT**

Application No.: 16-0202 **Applicant Name:** DSM Realty Corporation

SITE INSPECTION REPORT

File Name: DSM Realty Corp (Gold Meadow Farms Solar Array Project)

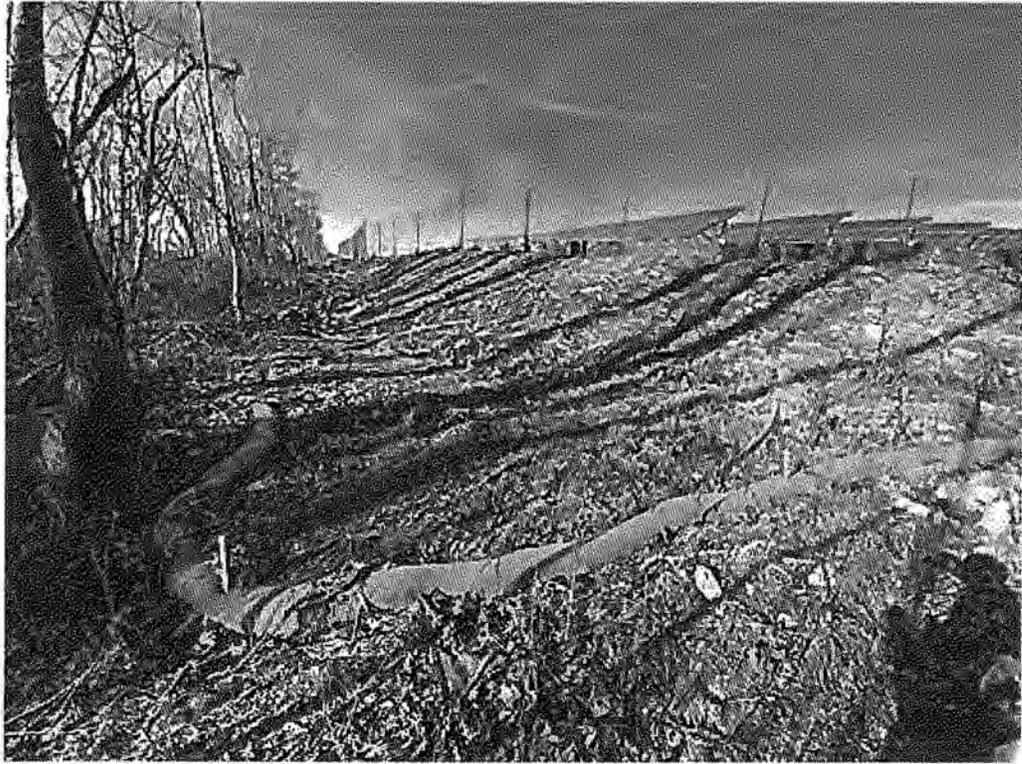
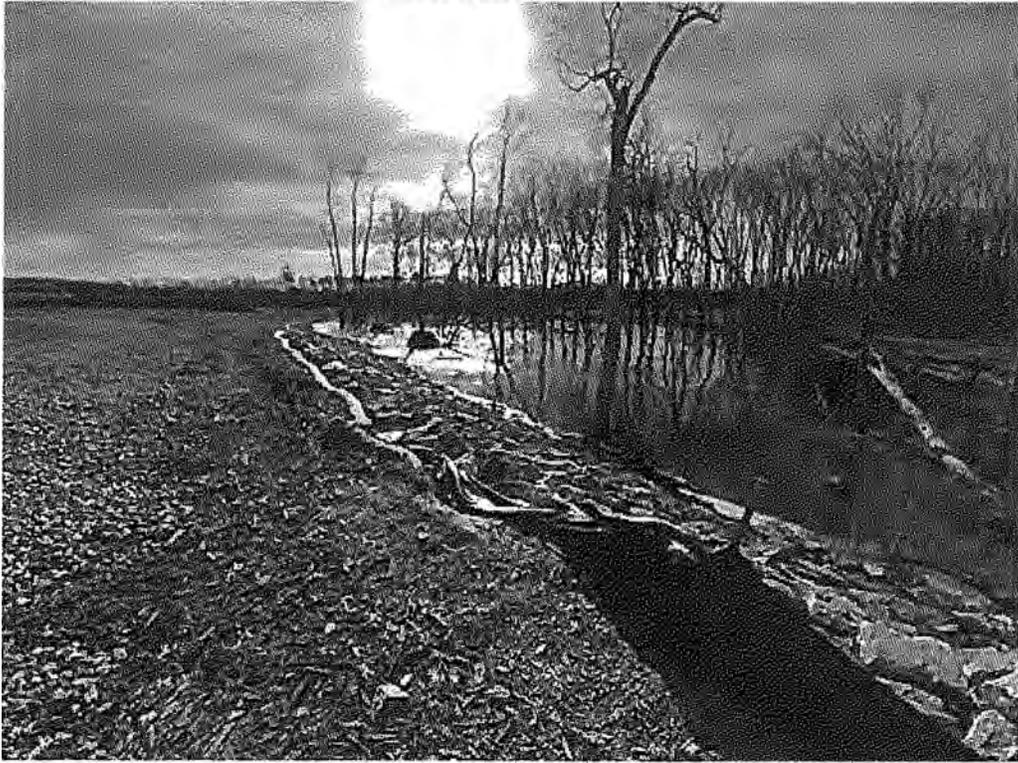
- In the southeast corner of the solar array adjacent to the off-site forested wetland near Newlight Street in West Warwick, erosion controls could be bolstered in this area (see photo on left below where they are breached).
- Please check erosion controls along Wetland F. Additional erosion controls measures have been installed, but still they are inadequate based on the site's topography and lack of vegetative cover (see photo on right below).
- Portions of the wattles along the road between Wetlands E and F should be reinforced where no longer functioning.
- Please ensure that erosion controls remain functioning along Wetland C. They appeared to be OK at the time of my inspection
- Please also check the southwest corner. I received a complaint that they were not functioning in this area.
